**SAFETY AUDIT OF THREE RAILWAY BRIDGES IN
MADURAI DIVISION OF SOUTHERN RAILWAY**

**A Report on
FIELD INSPECTION AND STRUCTURAL DESIGN CHECK OF
1377A PRESTRESSED CONCRETE GIRDER BRIDGE, AT
KODAI ROAD**

**MADURAI DIVISION
SOUTHERN RAILWAY**

**DEPARTMENT OF CIVIL ENGINEERING
INDIAN INSTITUTE OF TECHNOLOGY MADRAS
CHENNAI – 600 036**

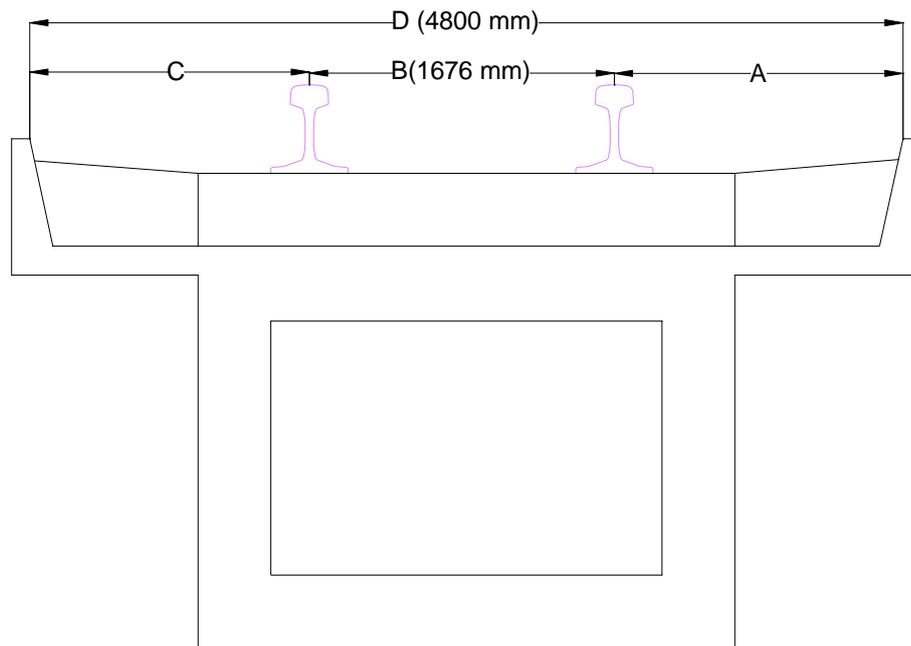
Figure 4 Cross section of rails for PSC Girder Bridge 1377A

Location	A (in mm)	C= D-(A+B) (in mm)	Eccentricity $E = (A-C)/2$
A1	1475	1649	-87
P1	1370	1754	-192
P1	1367	1757	-195
P2	1487	1637	-75
P2	1520	1604	-42
P3	1555	1569	-7
P3	1560	1564	-2
P4	1685	1439	123
P4	1682	1442	120
A2	1800	1324	238

From the above, Table 2, it is evident that Center line of rails are eccentrically shifted along the transition curve during the movement of trains. Movement of rails along the transition curve causing eccentricity in the loading is a serious issue. In addition to the data provided by the railway engineers, independent measurements were taken during site visit to the bridge. The shift in rail center line was measured at random locations and the eccentricity was found to be less than 100mm which is within the limits specified in railway manual. However, the high values of eccentricity reported by railway engineers indicate potential problems that could arise and this needs to be investigated thoroughly. It is recommended to study this issue in greater detail through instrumentation in Phase-2 of the project.

Further measurements are required for ascertaining the safety and stability of the bridge. In particular strain gauges should be installed along various sections along the bridge in order to evaluate the torsional effects of eccentric loading. Since the loss of prestress is unknown, deflection measurements are also recommended.

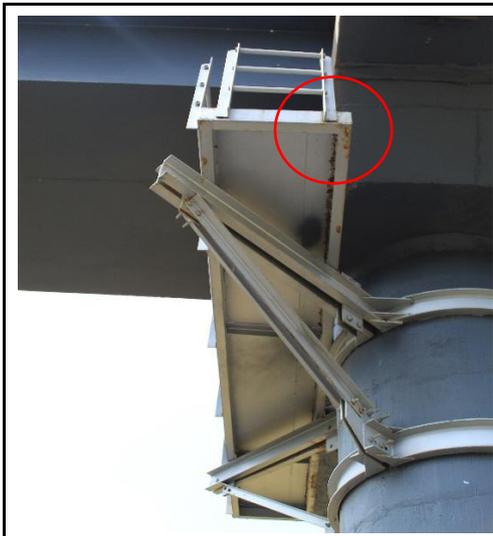
IMAGE NO.	A.1
BRIDGE ID	1377A
SPAN NO	5
COMPONENT	Inspection platform
COMPONENT ID	IP4
DEFECT	Corrosion
OBSERVATION	Corrosion observed in inspection platform floor beam
CONDITION STATE	Preventive maintenance

- ii. Moderate corrosion is found on steel inspection platform members, which needs anti corrosion treatment and frequent maintenance.
- iii. Drainage spouts under the deck slabs were missing. Missing drainage spouts needs to be reinstalled before next rainy season.
- iv. No severe defect is observed in the bridge components.
- v. Stress values are within limit for the 25t loading condition given in the Bridge Rule;
- vi. Deflection for the PSC girder is within the allowable deflection;
- vii. For the given sections and 25t loading condition without considering the defects, the structure is safe and stable;
- viii. The assumptions made in the design due to non-availability of data need to be verified.

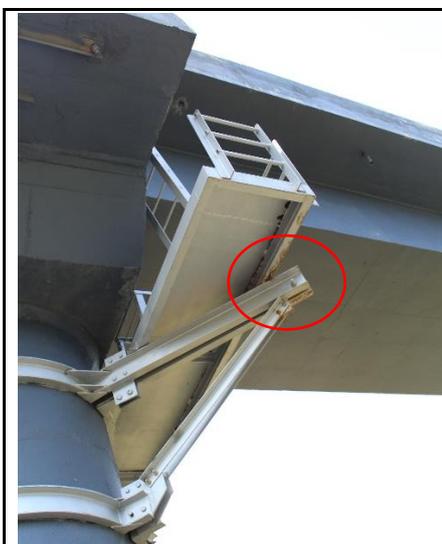
IMAGE NO.	A.2
BRIDGE ID	1377A
SPAN NO	4
COMPONENT	Inspection platform
COMPONENT ID	IP4
DEFECT	Corrosion
OBSERVATION	Corrosion observed in inspection platform floor beam & bracings
CONDITION STATE	Preventive maintenance

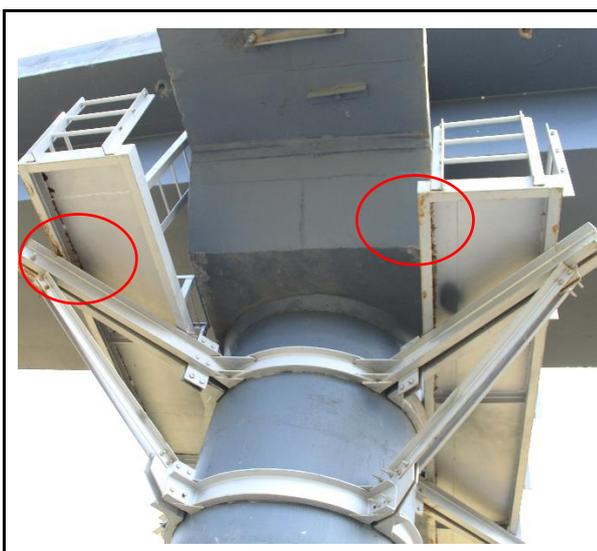
IMAGE NO.	A.3
BRIDGE ID	1377A
SPAN NO	4
COMPONENT	Inspection platform
COMPONENT ID	IP3
DEFECT	Corrosion
OBSERVATION	Corrosion observed in inspection platform floor beam & bracings
CONDITION STATE	Preventive maintenance

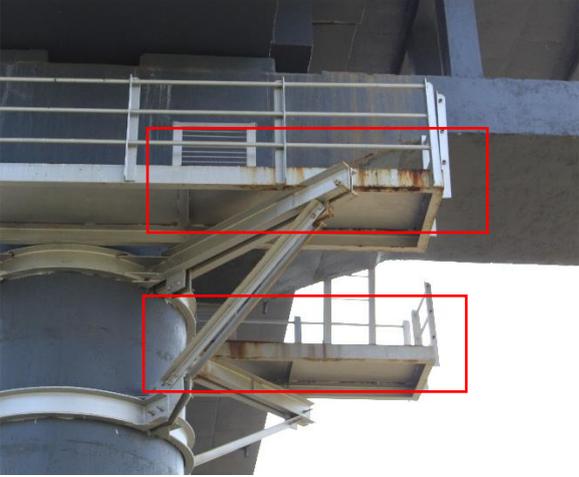
IMAGE NO.	A.4
	BRIDGE ID	1377A
	SPAN NO	1
	COMPONENT	Inspection platform
	COMPONENT ID	IP1
	DEFECT	Corrosion
	OBSERVATION	Corrosion observed in inspection platform floor beam & bracings
CONDITION STATE	Preventive maintenance

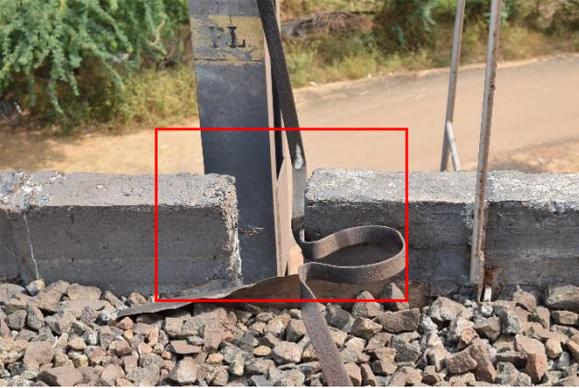
IMAGE NO.	A.5
	BRIDGE ID	1377A
	SPAN NO	2
	COMPONENT	Deck slab
	COMPONENT ID	D
	DEFECT	Wide gap
	OBSERVATION	Wide gap at expansion joint location
CONDITION STATE	Preventive maintenance

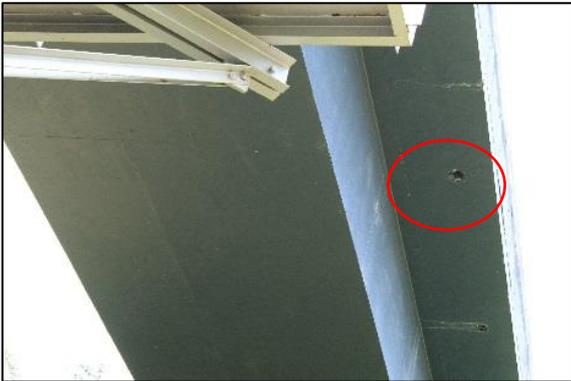
IMAGE NO.	A.6
	BRIDGE ID	1377A
	SPAN NO	3
	COMPONENT	Deck slab
	COMPONENT ID	D
	DEFECT	No drainage spout
	OBSERVATION	Drainage spout not available below the deck slab
CONDITION STATE	Preventive maintenance

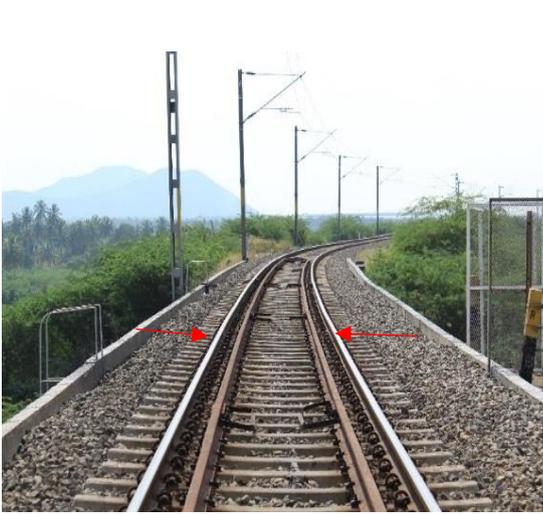
IMAGE NO.	A.7
	BRIDGE ID	1377A
	SPAN NO	3
	COMPONENT	Deck slab
	COMPONENT ID	D
	DEFECT	Rail eccentricity
	OBSERVATION	The center line of the rail was eccentric
	CONDITION STATE	Structural

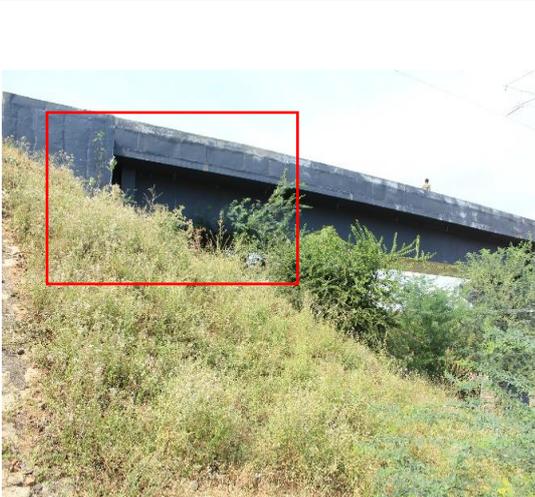
IMAGE NO.	A.8
	BRIDGE ID	1377A
	SPAN NO	1
	COMPONENT	Protection works/Abutment
	COMPONENT ID	PW1/A2
	DEFECT	Vegetation growth
	OBSERVATION	Growth of vegetation found on protection works and near abutment
CONDITION STATE	Preventive maintenance

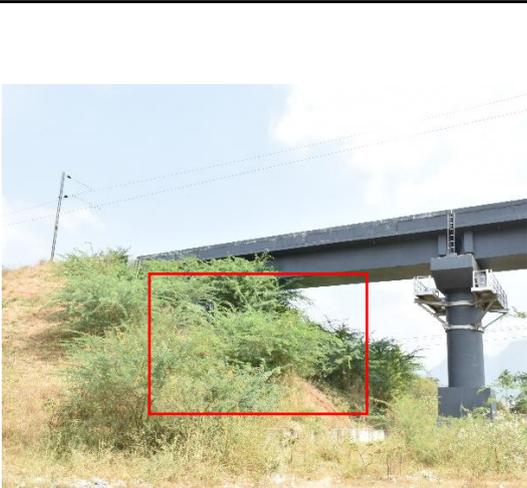
IMAGE NO.	A.9
	BRIDGE ID	1377A
	SPAN NO	1
	COMPONENT	Protection works/Abutment
	COMPONENT ID	PW1/A1
	DEFECT	Vegetation growth
	OBSERVATION	Growth of vegetation found on protection works and near abutment
CONDITION STATE	Preventive maintenance
