**REPORT**  
**THIRD PARTY AUDITING OF RAILWAY BRIDGES (PHASE I)**

(Job No: CED/CON/TMMP/SAS/2019312)

**Br. No. 872A (1 × 21.5m) RCC Girder at km. 623/300-400 between  
Tirunavaya and Tirur station**

**SOUTHERN RAILWAY PALGHAT DIVISION**

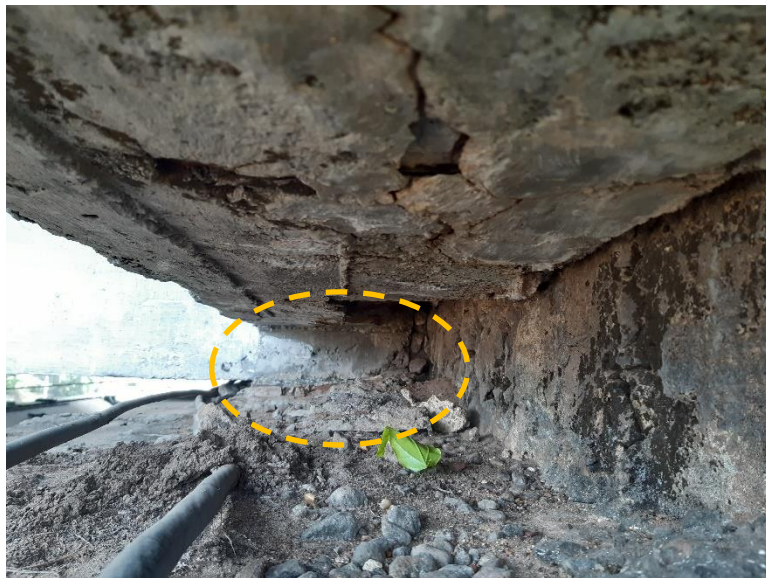
Figure 4. Bearing under girder

| Sl. No. | Elements | Remarks |
|---|---|---|
| 2 | Bearing | Bearings are found to be in good condition. However spalling of concrete is noted near the bearing (Fig.4) which shall be repaired. |

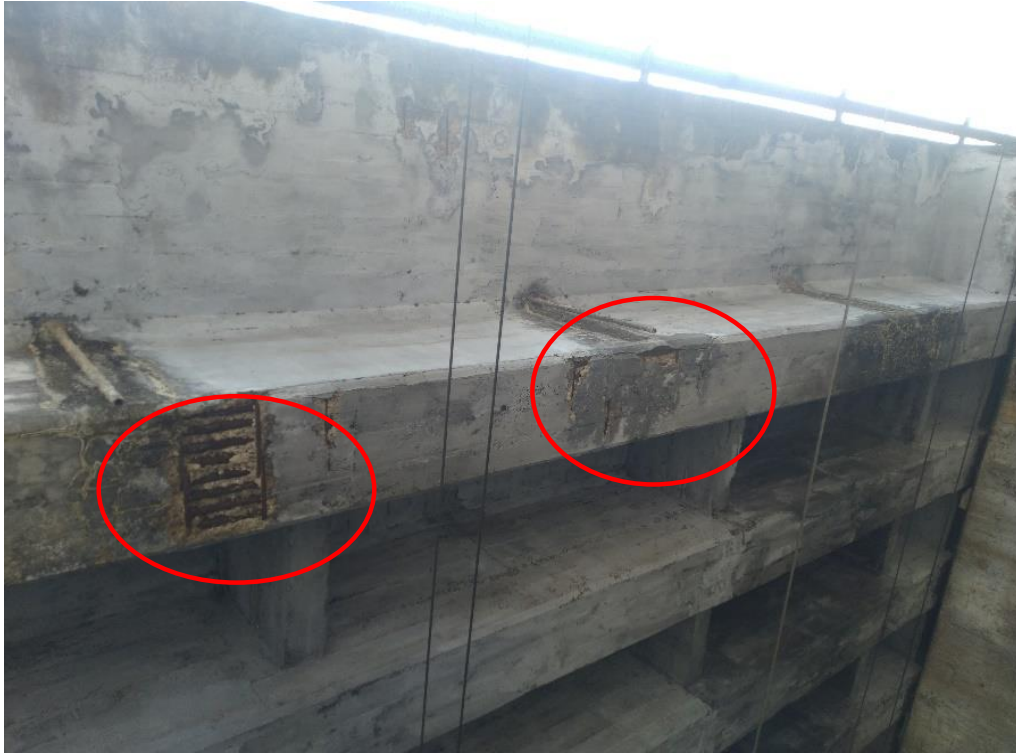
| Sl. No. | Elements | Remarks |
|---|---|---|
| 3 | Main Girder | Side cover and bottom cover concrete spalling are noticed at several locations (Especially at end girders) as shown in Figure 5 and Figure 6. |

Figure 5. Concrete cover is spalled and reinforcement is exposed at the mid span of end main girder at Calicut side

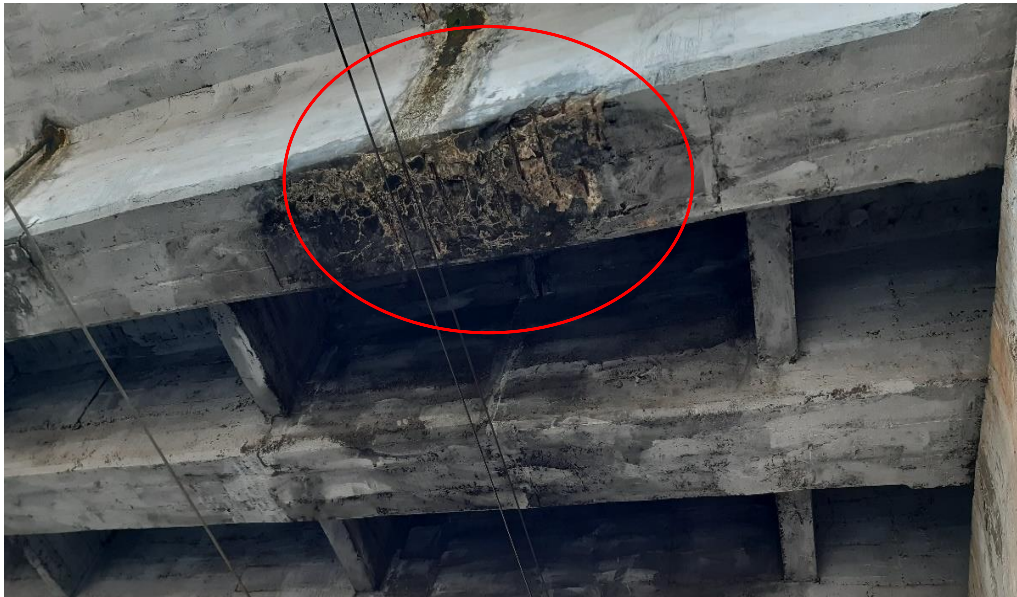
Figure 6. Concrete cover is spalled and reinforcement is exposed at near the support of end main girder at Calicut side

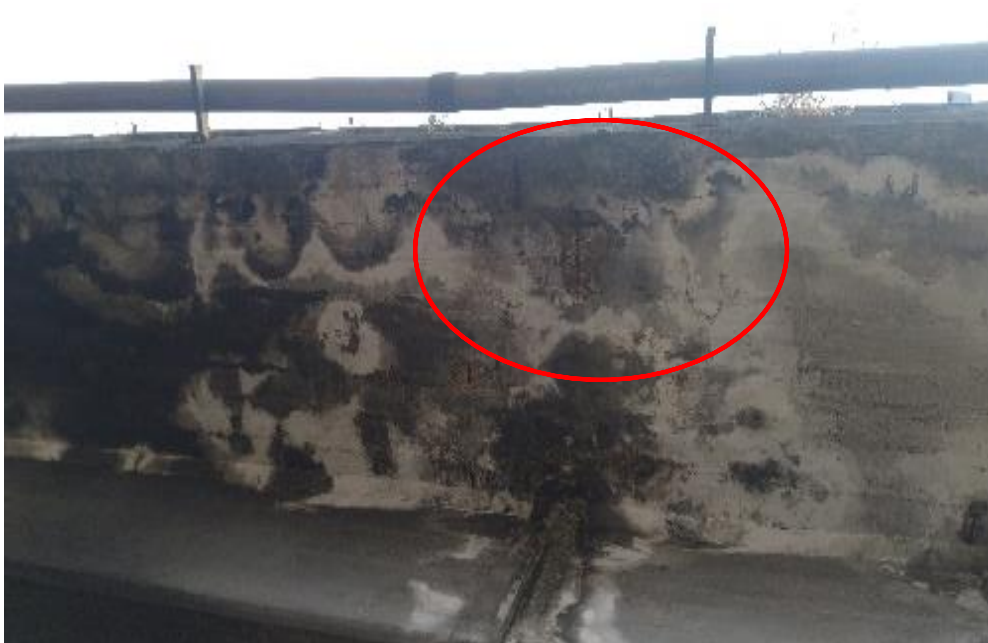
| Sl. No. | Elements | Remarks |
|---|---|---|
| 5 | Deck slab | Epoxy coating is spalled and re-bar is exposed at several locations. (Especially at end projections after end girders) as shown in Figure 7. |

Figure 7. Concrete is spalled and rebar is exposed at bottom of the deck slab at Calicut side

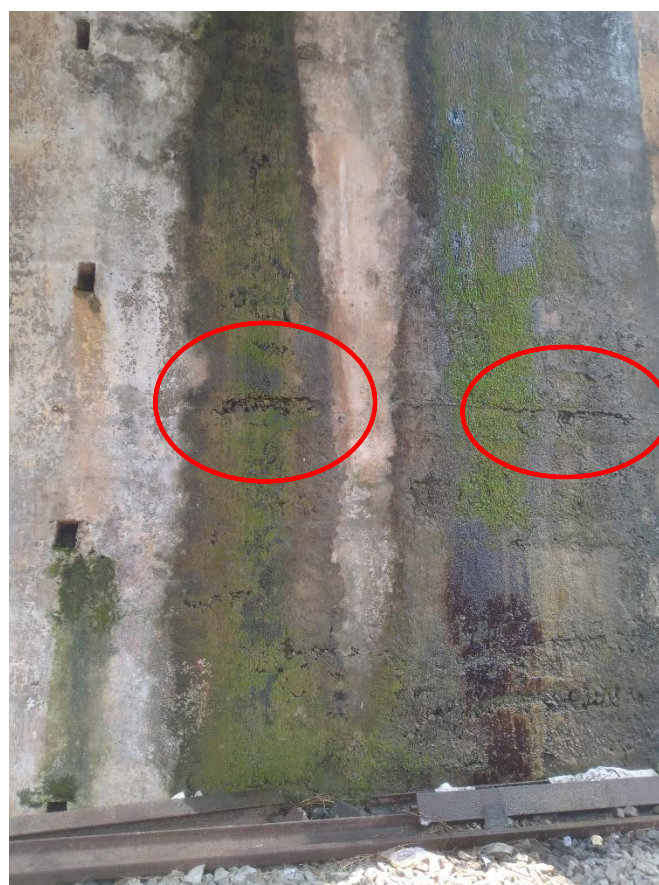
| Sl. No. | Elements | Remarks |
|---|---|---|
| 1 | Abutment | Both abutments are found in sound condition. No cracks / bulging of concrete is noticed. Spalling of concrete is noticed at some locations on abutment at eastern side as shown in Figure 8. |

Figure 8. Spalling of concrete at abutment at eastern side

| Sl No. | Test point | Location | Estimated compressive strength (MPa) |
|---|---|---|---|
| 2 | B | Abutment at Eastern side | 24.62 |

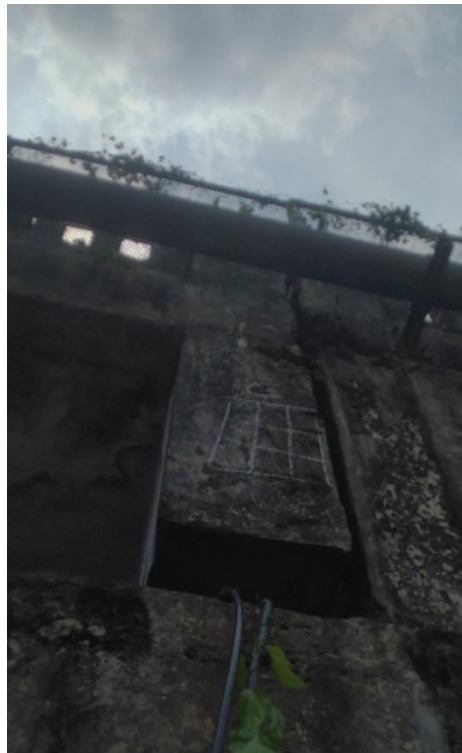
Figure 10. Testing points at Cross girder at western side

| Sl No. | Test point | Location | Estimated compressive strength (MPa) |
|---|---|---|---|
| 3 | C | End cross girder at western side | 22.49 |
