यांत्रिक **MECHANICAL**

Madurai Coaching Depot

INNOVATION:-

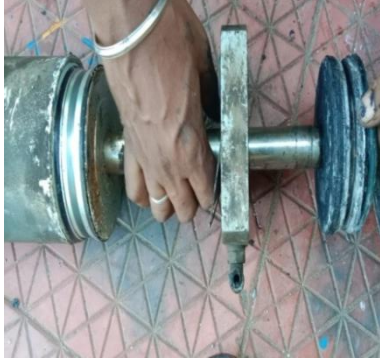
Piston Disc (Air side) found good and intact

The Non-working of Pressurised Flushing System (PFS) in bio toilets is one of the maintenance challenge being faced by the coaching depots mainly due to worn out actuating piston assembly. On detailed examination, it is noticed that out of 2 actuating pistons in the pressuring cylinder, one on water end and other on pneumatic end. The water end are getting eroded on service due to salt deposits and abrasion due to minor floating particles in the water. The efforts made to replace the worn-out parts with OEMs did not yield results due to their poor response and instead of child parts, OEMs are interested to offer complete cylinder assembly, which costs around Rs.22000 per cylinder.

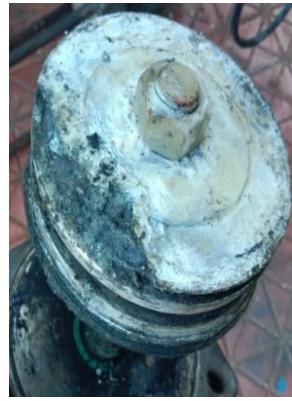
Piston Disc (Water side) found decayed

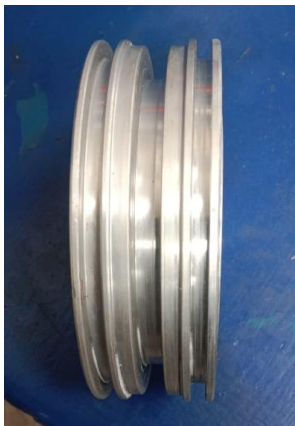
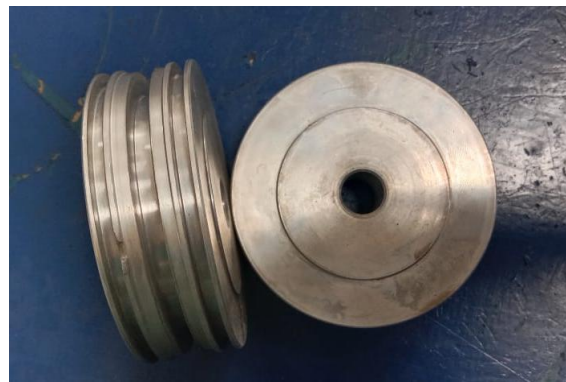
Final Product (After CNC lathe Work)

The team drafted its own design and developed 5 new pistons duly purchasing raw materials and machining in a CNC machining centre at a total cost of Rs.2100 per piston. One such piston was fitted in the PFS cylinder of Coach Number LWSCZ 216440 on 11.11.023 and so far it has been working satisfactorily. . This not only solves the problem of worn-out pistons but also potentially provides a more economical solution for maintaining the PFS.

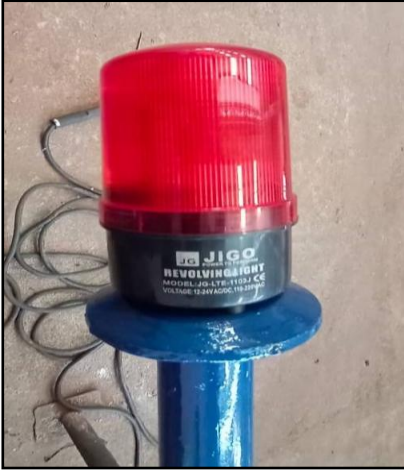
| Blinking rotary signal light with siren | Metal clamp with mounting bolt nuts | Metal clamp with mounting bolt nuts |

The signaling device is composed of a robust 3-meter galvanized iron pole, featuring a blinking rotary signal lamp at one end and secure clamp fittings for mounting at the other end. To ensure safety and durability, the internal wiring of the blinking rotary signal lamp is meticulously routed through the pole and encased in a corrugated tube conduit. The operational switch for the entire setup is conveniently located beneath the pit line, mounted on the catwalk pillar.

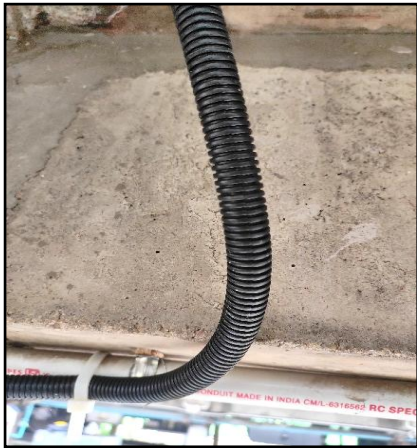
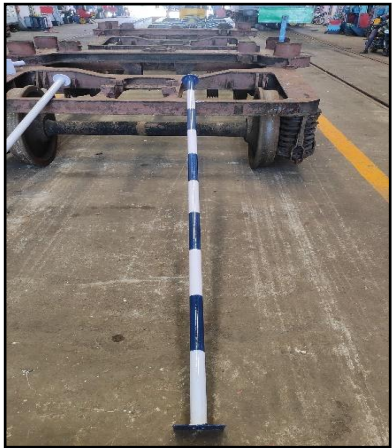
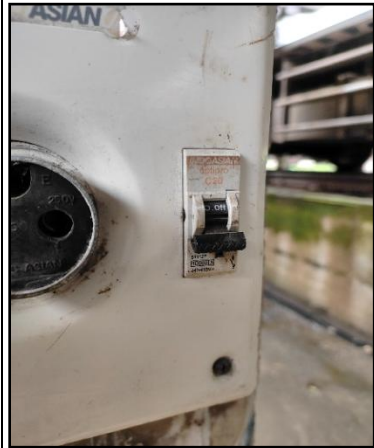
| Spring hose pipe for wiring | 1 1/2" GI Pipe Pole for light mounting | Single pole MCB switch |

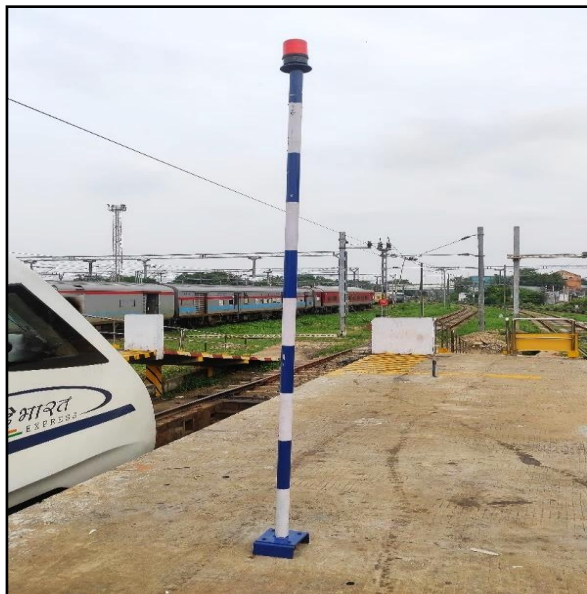
Signal pole installed on east side
of pit line No. 3

Before energizing the OHE, operating staff are required to activate the blinking rotary signal lamp by toggling the MCB switch located beneath the pit line on the catwalk pillar. This action triggers the rotary signal light, emitting a cautionary red light and siren voice to alert staff about the energized condition of the overhead power line. Following the completion of the de-energization process, the operating staff can deactivate the indicator by turning off the MCB switch.

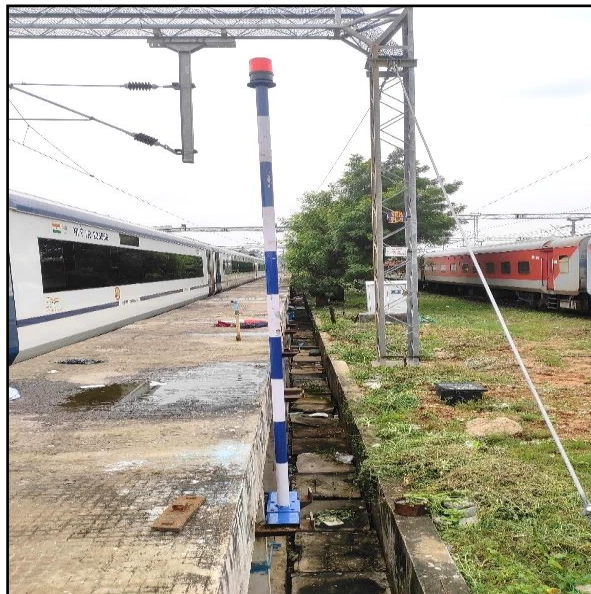
Signal pole installed on west side
of pit line No. 3

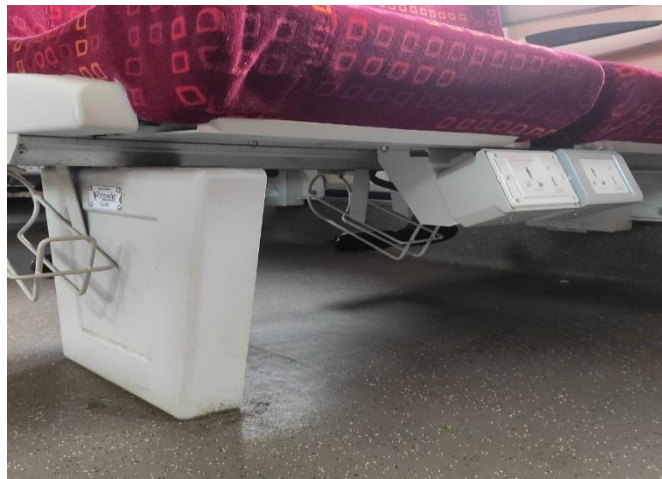
Before Modification

As per the current design, passengers have to utilize the bottle holder attached to the seat in-front. Recognizing the absence of a front seat in the middle row and the presence of a wooden snack table instead, a thoughtful modification initiative was undertaken, successfully incorporating extra bottle holders into the middle row to enhance passenger convenience and accessibility during travel. The modification was also tested to see if there is any inconvenience to the seating of a passenger due to it.

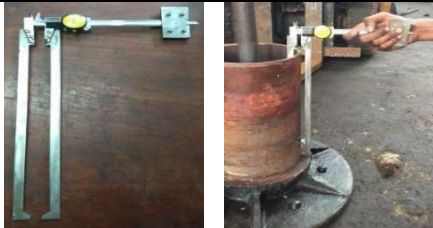
| Si.No | Deatiled Description | Picture |
|---|---|---|
| 3 | <p><u>Plunger wall thickness measuring Caliper</u></p> <p>To measure the wall thickness of Buffer plunger through out a full length a extension was made and fitted with vernier caliper arms.</p> | |

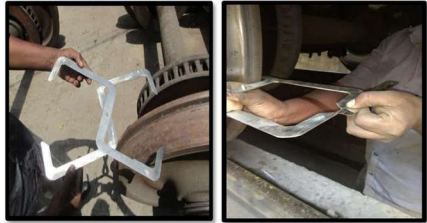
| Si.No | Deatiled Description | Picture |
|---|---|---|
| 4 | <p><u>Gauge for Measuring Web Rim Thickness</u></p> <p>Scissor type calliper made of stainless steel was developed to measure Web Rim Thickness. (web thickness of 14mm+3 or 17mm+3)</p> | |

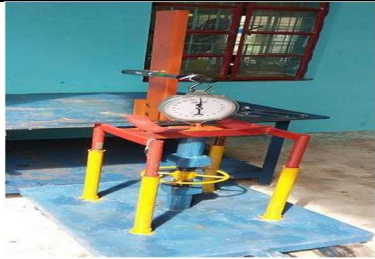
| Si.No | Deatiled Description | Picture |
|---|---|---|
| 7 | <p><u>Torque Wrench Calibration Test Bench</u></p> <p>To ensure the accuracy of torque wrench the test bench with pre set torque value was fabricated.</p> | |

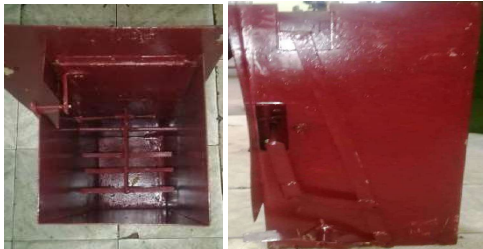
| 8. | <p><u>Pedal Operated Dustbin for Multi Purpose</u></p> <p>An innovation made in the dust bins by single operation of foot pedal. The dustbin will open, and at the same time already available garbages will be squeezed.</p> | |

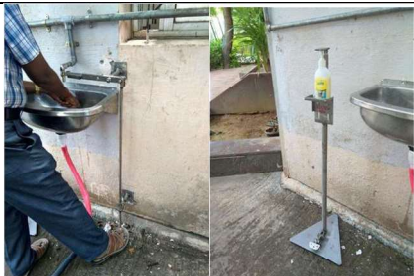
| 9 | <p><u>Foot Pedal operated Liquid soap dispenser and Hand wash</u></p> <p>During COVID-19 pandemic, foot operated Liquid soap dispenser and foot operated water tap was developed to avoid using of hands.</p> | |

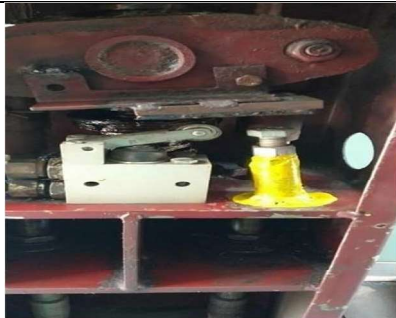
| 14 | <p><u>Provision of Stopper in Hand Brake Arrangement</u></p> <p>The stopper was made to avoid damaging of the limit switch in LWLRRM Hand Brake.</p> | |
