REPORT
THIRD PARTY AUDITING OF RAILWAY BRIDGES (PHASE I)

(Job No: CED/CON/TMMP/SAS/2019312)

**Br. No. 2272E (1 × 12.20m) RCC Girder at km. 155/691 On Quilon-
Trivandrum section of Trivandrum Division**

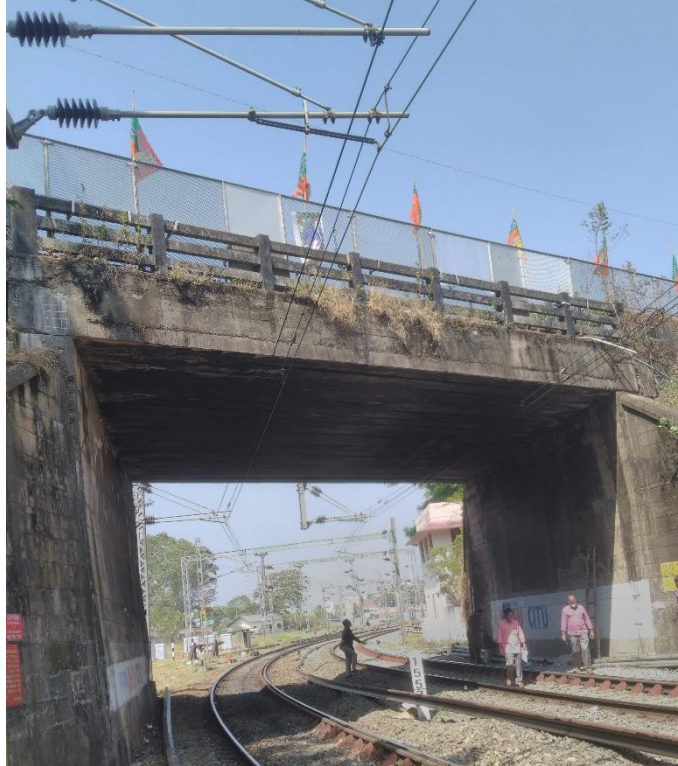
during the inspection. It is a RCC girder bridge with RCC precast I-section as girders with a span of 12.20m, supported on RCC abutments. The ROB is reported to be lifted to a height of 1.5m from a previous position. Photographs of the bridge showing various elements are shown in Figure 1 to Figure 3. One more visit and inspection was conducted on 05-03-2021 (Friday) for carrying out non-destructive testing.

Figure 1. View of Br.2272E Girder type RCC Bridge

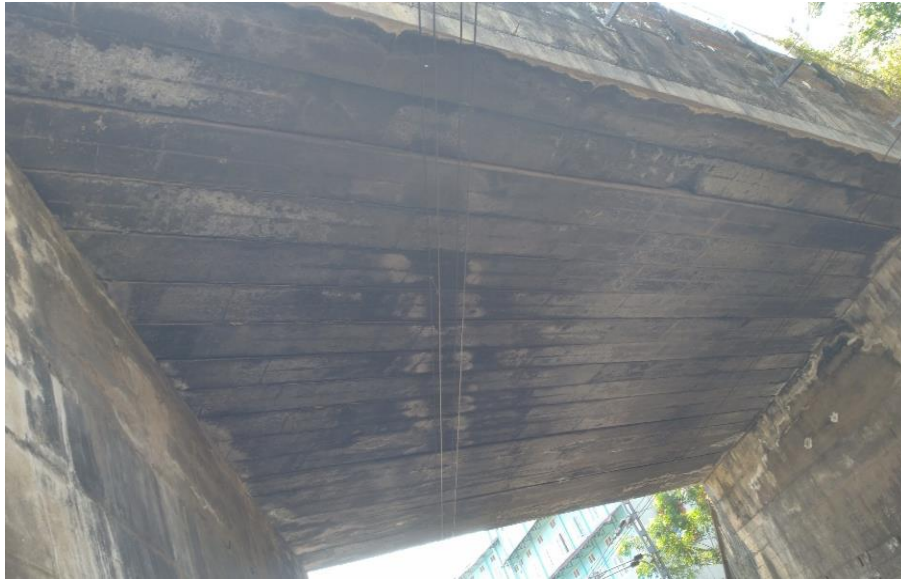
Figure 2. Bottom main beams

No distress was noticed on the different structural elements of the ROB during the inspection. All members were found in sound condition.

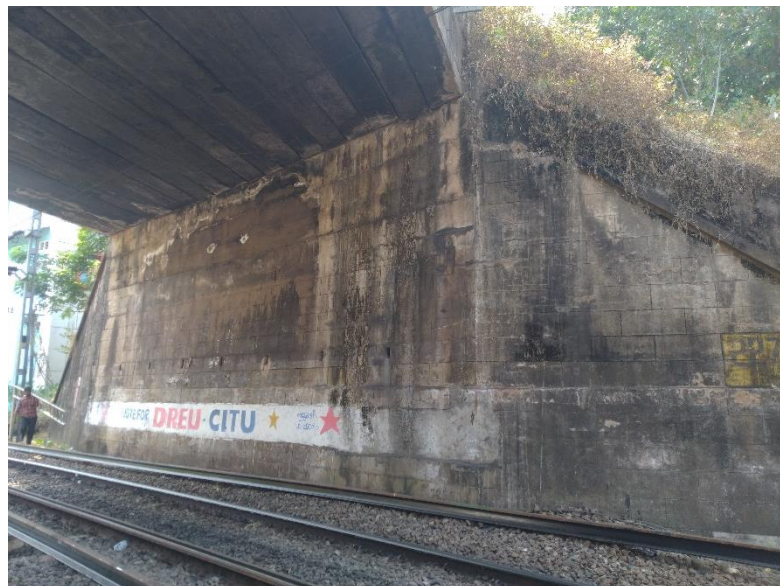
Figure 3. RCC Abutment

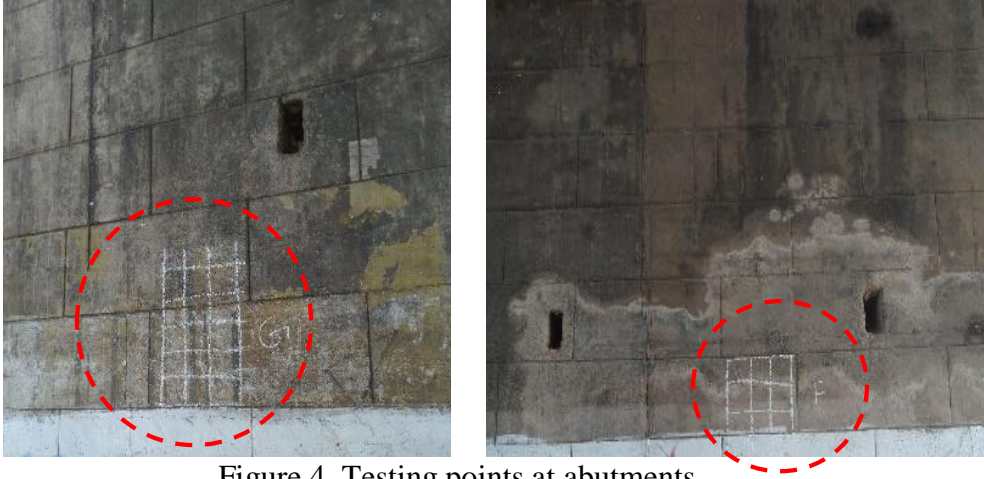
Sl No.	Test point	Location	Estimated compressive strength (MPa)
1	A	Abutment at eastern side	46.53
2	B	Abutment at western side	46.11
3	C	Top of abutment at eastern side (Lifted portion)	31.88
4	D	Girder at eastern side	57.06
5	E	Girder at western side	52.29

It is noted that the strength estimated by rebound hammer tests are representing very good concrete. Hence it is inferred that the structure is in safe condition.

Figure 4. Testing points at abutments

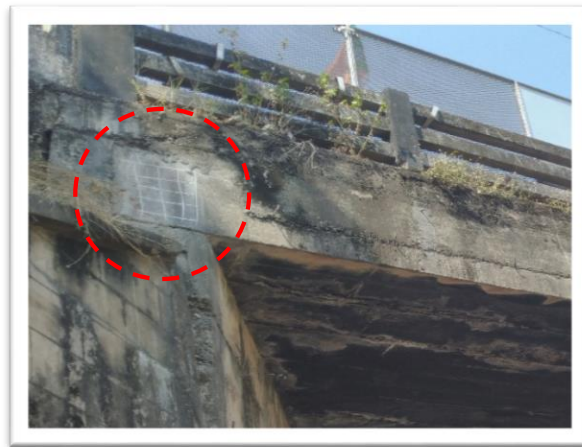
Figure 5. Typical testing point at girder

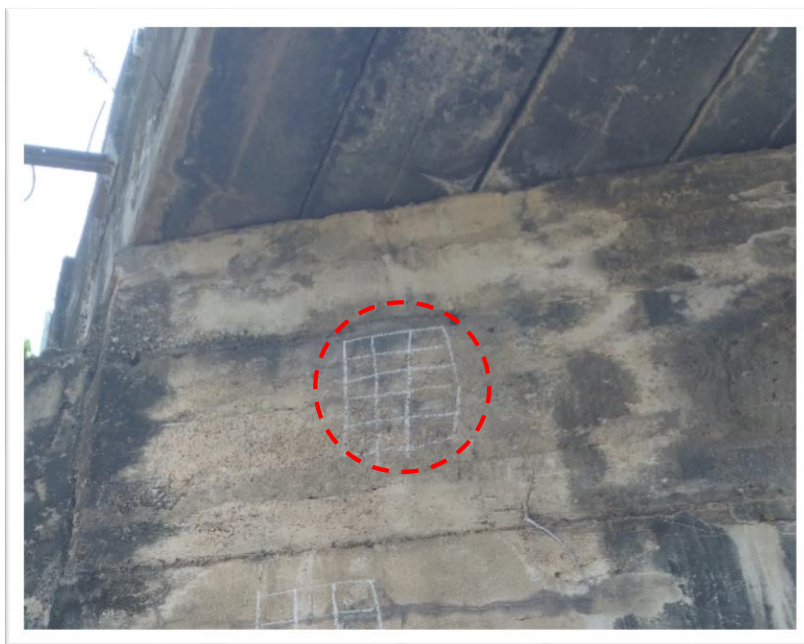
Figure 6. Testing point at top of abutment (Lifted portion)
