REPORT

THIRD PARTY AUDITING OF RAILWAY BRIDGES (PHASE I)

**Br. No. 1233 DN (12 × 12.19m) PSC Girder at km. 854/700 – 900
between Kumbla & Uppala stations**

**Department of Civil Engineering
NATIONAL INSTITUTE OF TECHNOLOGY CALICUT**

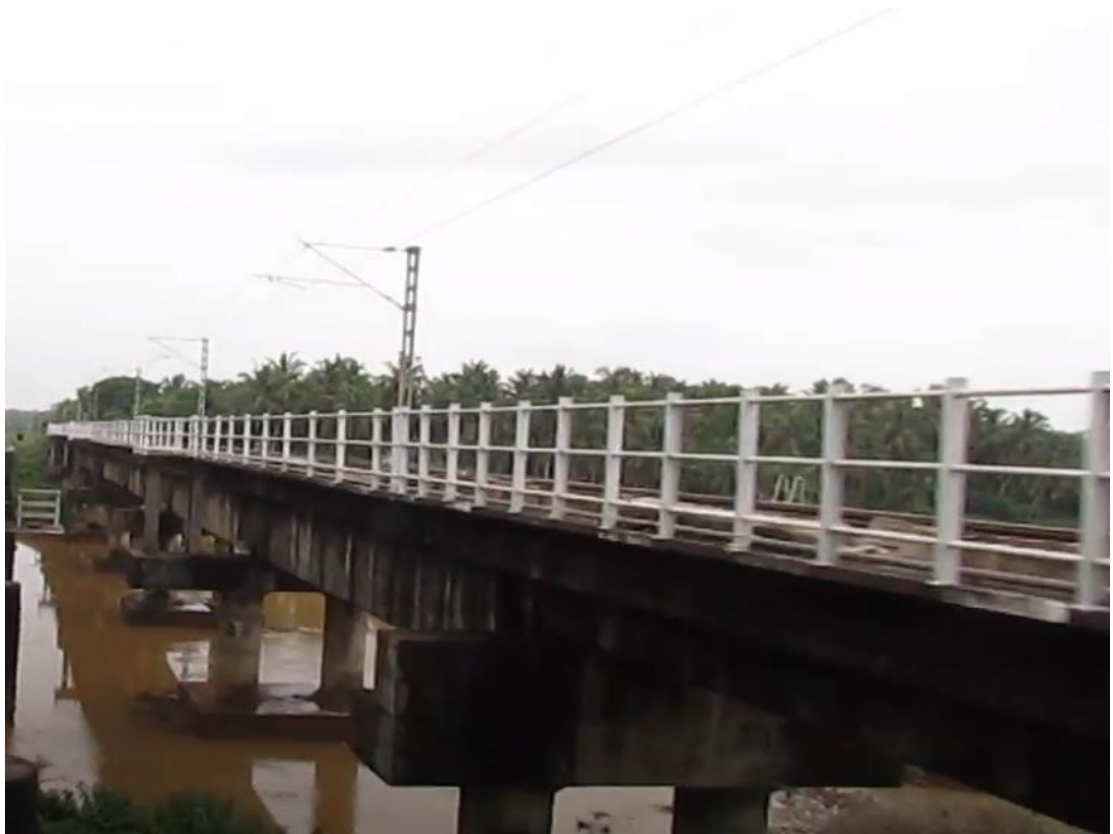
The visual inspections were carried out on the bridge on 10-01-2020 (Friday) at 9:30 am. Officials from Kannur Railway section were also present during the inspection. Photograph of the bridge is shown in Fig.1. The bridge is a PSC box girder bridge with twelve spans each of 12.19 m, supported on RCC piers. It was noted that the abutments were also of RCC.

Figure 1. View of Br.1233 DN between Kumbla and Uppala stations

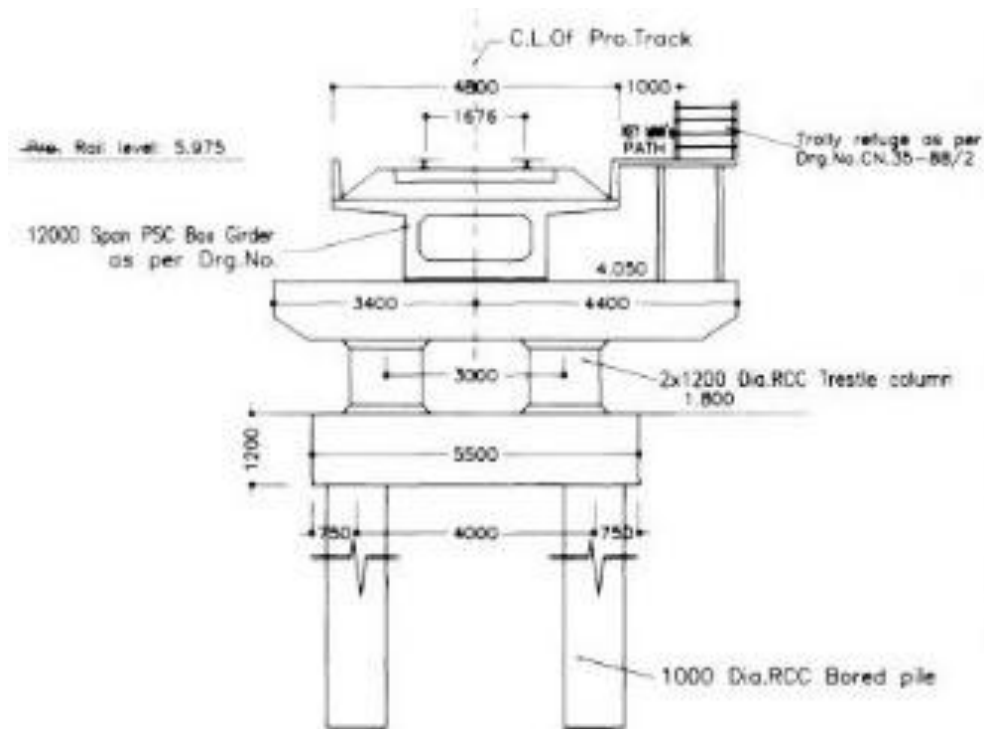
Based on the drawings available (Figures 2 to 4 shows the plan, elevation, and section of bridge) dimensions of various elements were verified. Overall conformity of the bridge with the available drawings were ensured. No distresses were noted and all the elements were assessed to be in good condition based on the visual examination conducted.

Figure 4. Section of PSC Girder of Br.No. 1233 DN

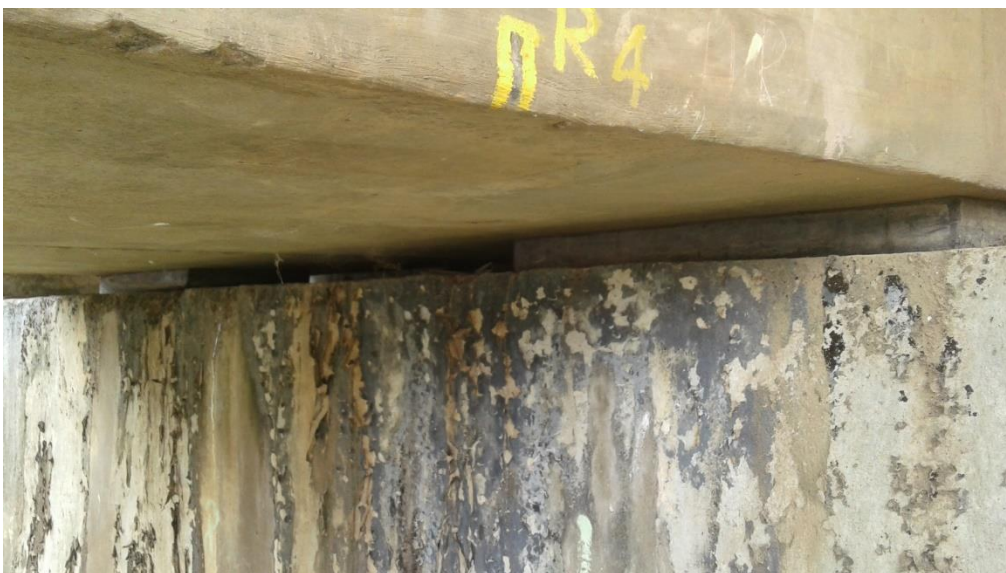
All the bearings were examined and were found in very good condition. Figure 5 to 9 show details of typical bearings.

Figure 5 Bearing

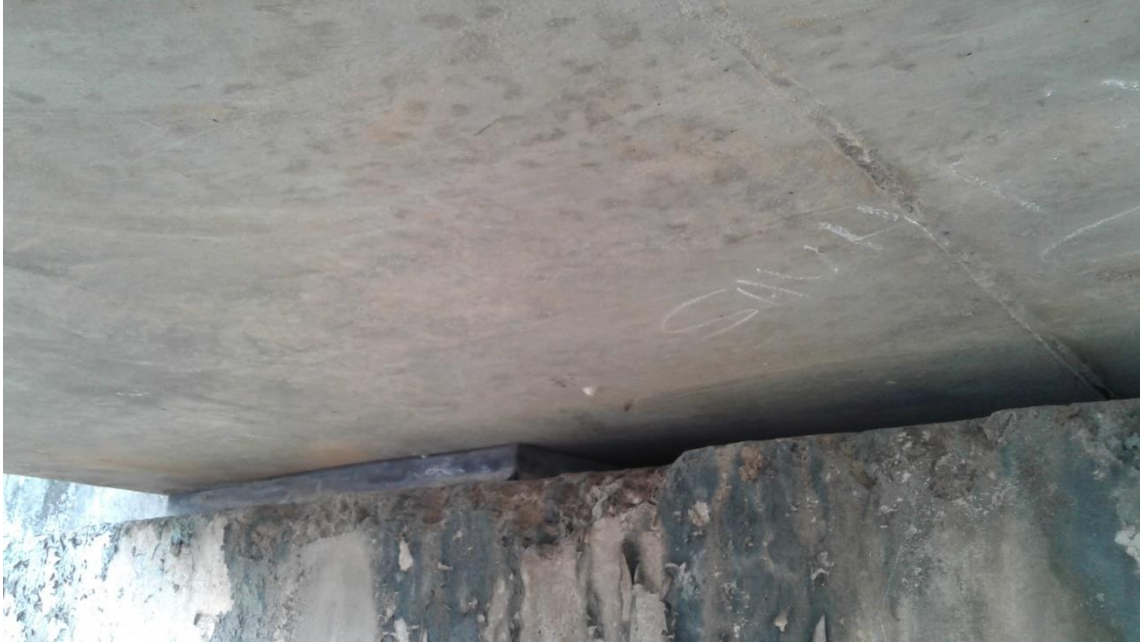
Figure 6 Close view of a bearing

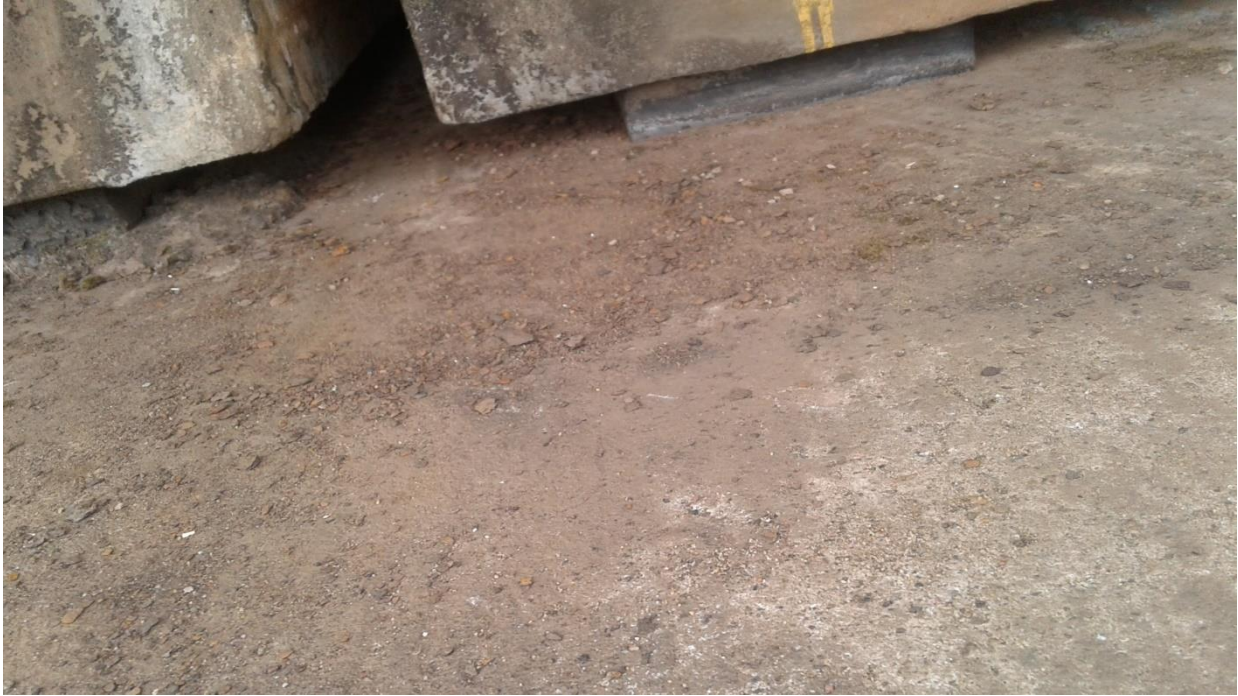
Figure 8 Close view of another bearing

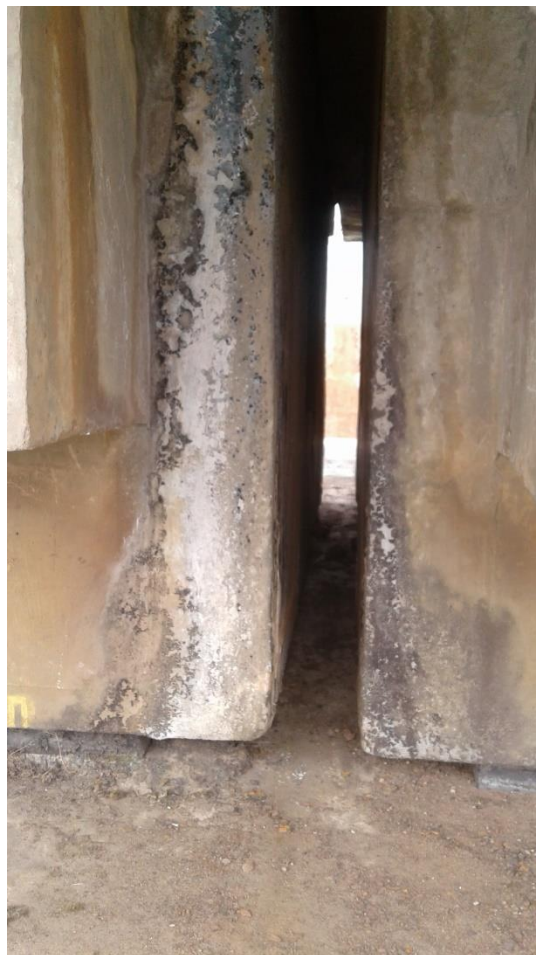
Figure 9 Another bearing – a different view
