**INNOVATIONS & SYSTEM IMPROVEMENTS UNDER TAKEN DURING THE YEAR 2008- 09&2009- 10  
PERTAINING TO MECHANICAL DEPARTMENT OF THIRUVANANTHAPURAM DIVISION**

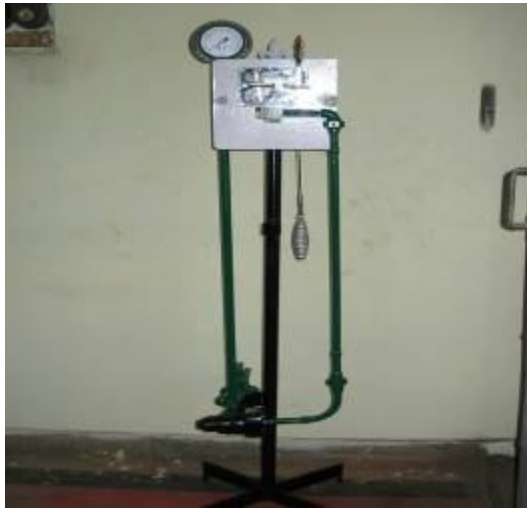
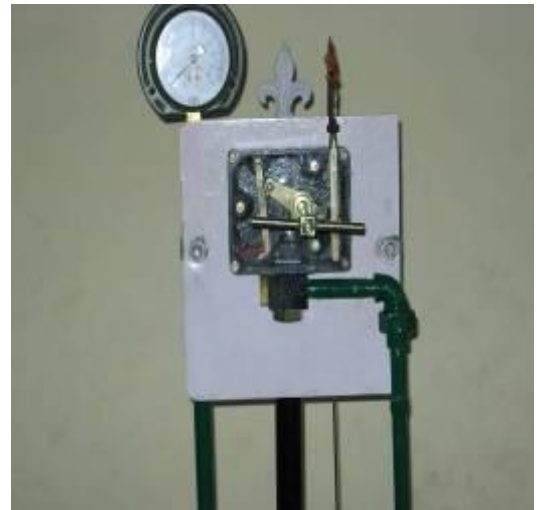
**Passenger Emergency Alarm System**

Working model of Passenger Emergency Alarm System for inter communication between Loco Pilots and passengers during emergencies developed at TVC coaching depot. It consists of Alarm pull chain, Passenger Emergency Alarm Signal Device, Passenger Emergency Alarm Valve, Isolating valve and pipe lines. When the alarm chain is pulled, air leaks out of the PEASD and it actuates the PEAV to reduce the BP pressure. Thus the driver gets the information by reduction in BP pressure and flow meter.

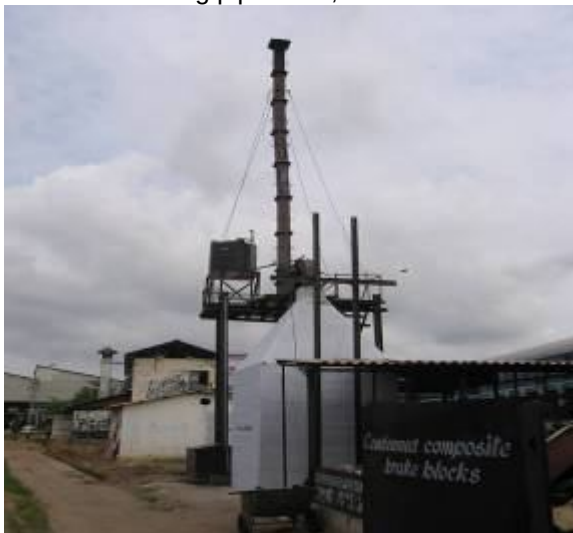
**Incinerator after fitment of cooling system**

**Cooling system provided in the chimney of Incinerator** to control temperature, emission of ash and other flying particles through exhaust flue gas of chimney developed at TVC coaching depot. This consists of a horizontal rectangular conduit made of steel and covered with stainless steel, 2 water cooling pipe lines, one external and other internal.

When the incinerator starts working, the valves of both internal and external cooling arrangements are opened and water is made to flow. The water used for external cooling arrangement is collected in the storage tank located at the floor and is re-circulated by means of a centrifugal pump similarly out let water of the internal cooling arrangement contains ash and other particles is collected in a tank, ash and other particles will remain in the tank and water is only allowed to flow out.

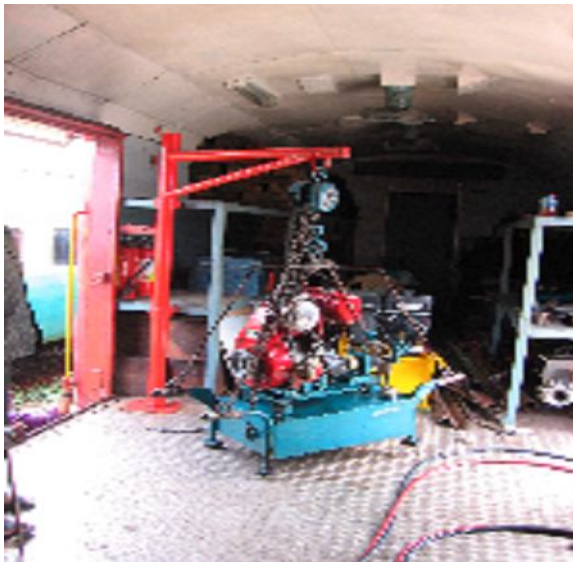
#### **Unloading arrangement in MFD coach**

**Unloading arrangement in MFD coach** - Gadget for unloading and loading of diesel/petrol power pack developed at TVC coaching depot. With this facility it is possible to unload power pack with one man power against 4 to 5 men manually. Damage caused to power pack due to manual unloading and loading can also be reduced with this arrangement.

This consists of a vertical pillar resting on thrust bearing and supported by two plain bearing support welded on to side frame. A pulley block of capacity one Tn. Is attached to the end of the pillar for enabling unloading and loading of power pack and other heavy components which are required for restoration work during accidents. A chain arrangement with 4 pipes has been attached as a lifting gadget.

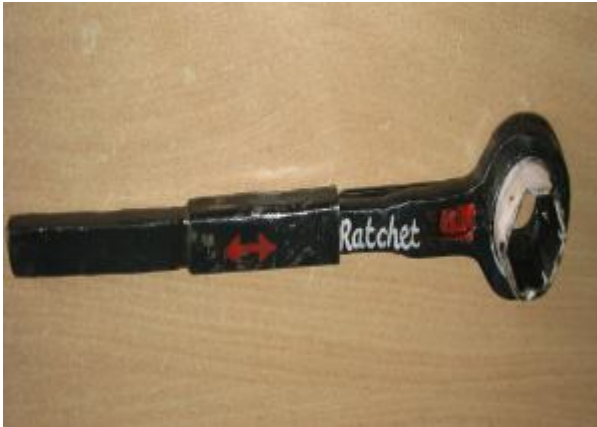
**Special tool for crown clearance adjustment in coaches**

Special tool for crown clearance adjustment in coaches developed at TVC coaching depot.

This consists of a hexagonal socket; across flat distance is 37 mm, height 20 mm, thickness 3.15 mm attached to one end of the specially designed 410 mm long ratchet spanner. This hexagonal portion is to be inserted in between crown bolt and rubber pad for adjusting crown clearance

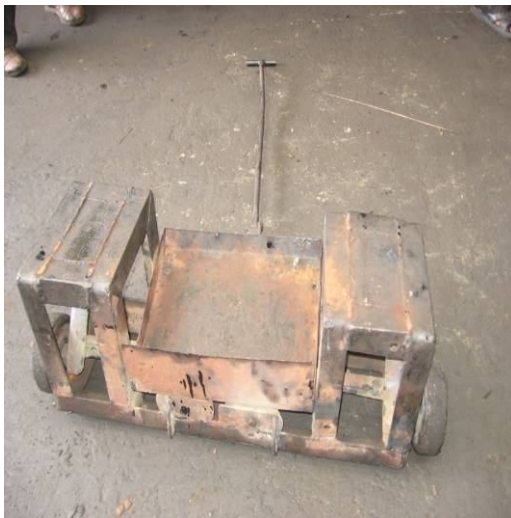
**Gadget for Bolster spring attention**

Gadget for bolster spring renewal developed at TVC coaching depot. This consists of a metallic frame made of angle iron of size 50 x 50 x 7 mm fabricated to the size: length – 830 mm, breadth – 230 mm & height – 325 mm.

The fabricated frame has been provided with 2 spring loaded wheels, with this, the gadget can be easily placed underneath the bottom bolster by simply rolling and pushing. When the gadget is loaded by placing underneath the bottom bolster, the spring arrangement and a lever attached to it disengages the wheels from the taking load so that the load exerted by the bottom bolster is born by the gadget only and not eh wheels. One pair small wheels attached with handle are for easy movement of gadget along the floor.

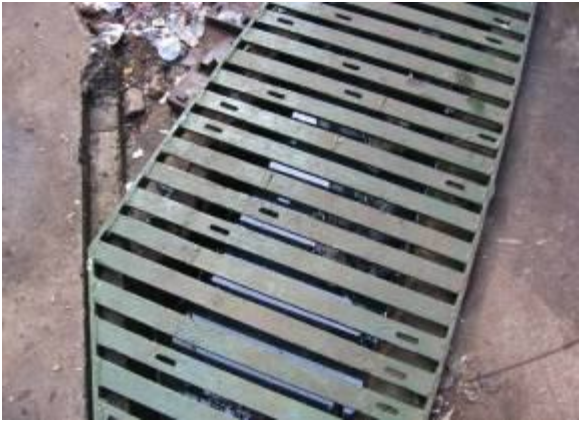
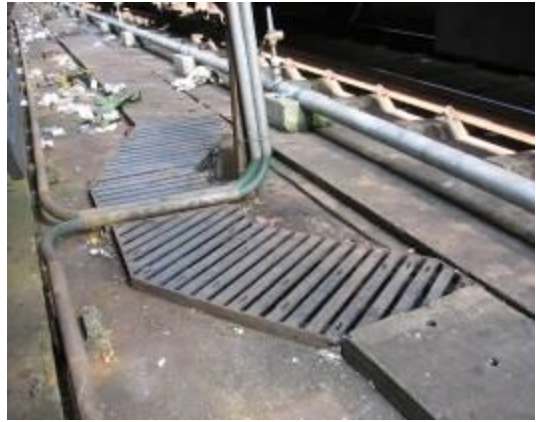
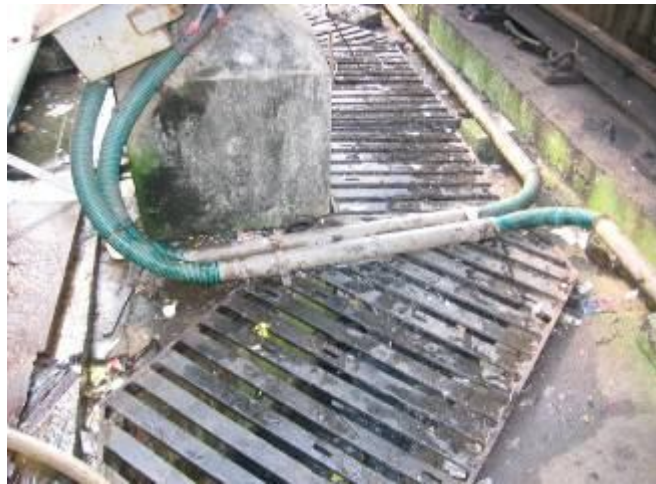
**Fabricated steel grates in between Pit 1 and PF 5**

Fabricated drain grate in between Pit 1 and PF 5 To cover the drain duct with fabricated steel grates which enables staff can walk safely and sediments and waste does not settle over and near the steel grates developed at TVC coaching depot.

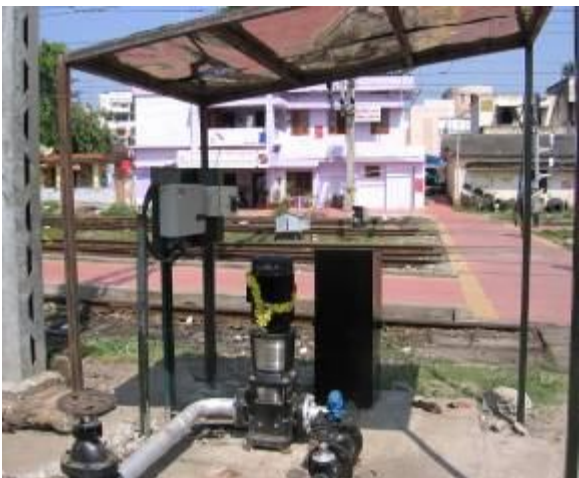
**Booster Pump**

**Booster Pump provided in between PF 3 & PF 4** for increasing water pressure and speedy filling of water in coaches booster pump procured, installed and commissioned in between PF 3 & PF 4 at TVC coaching depot.

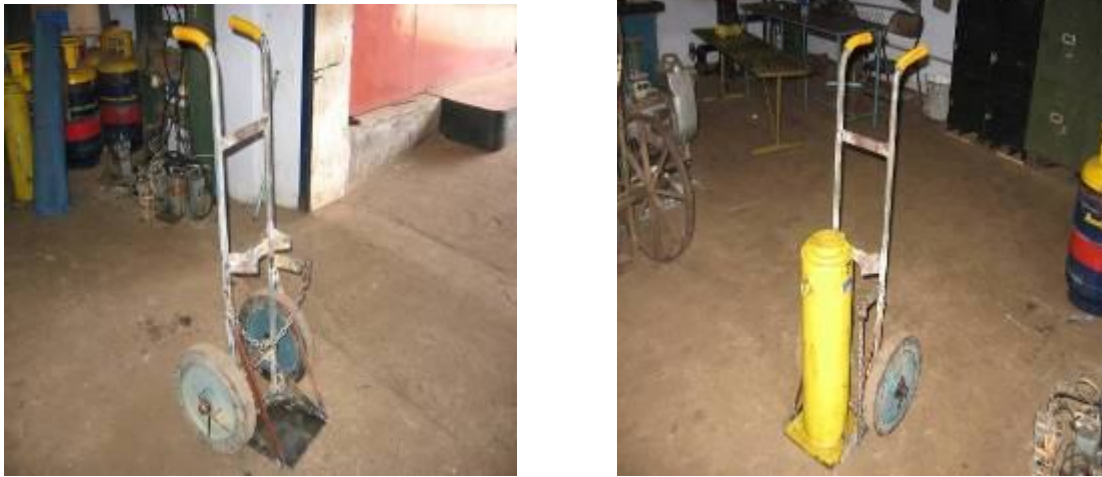
**Special trolley for transportation of jacks.**

**Special trolley** for transportation of jacks from coaching depot to pit line for 'V' belt changing developed at TVC coaching depot. It consists of a steel frame with special base with two wheels. One safety chain has been provided to secure the jack with the frame.

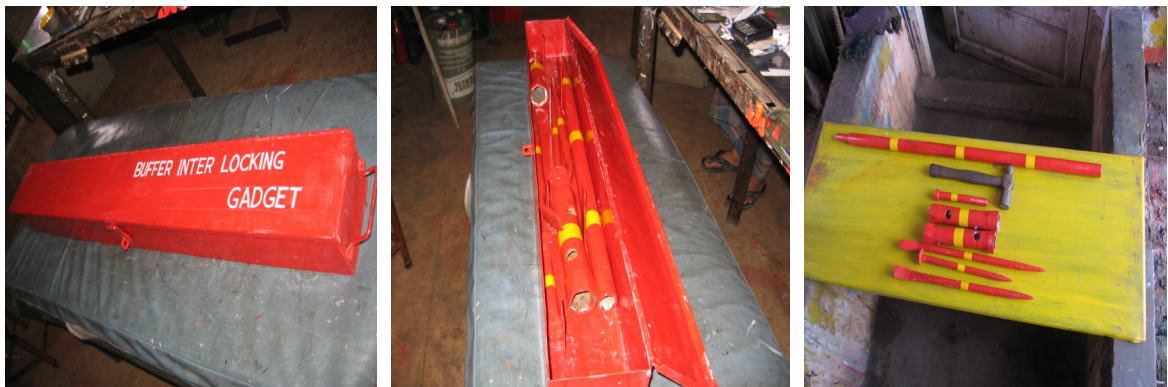
**1.Tool kit for attending buffer inter locking.** Immediately on getting information, staff can proceed with this tool kit to release the buffer inter locking. This tool kit is developed at TVC coaching depot consists of Box spanner (36mm size) – 2 Nos., Tommy bars – 2 Nos., Pointed tool – 1 No., Hammer – 1 No., Leverage – 1 No. & Lever – 1 No.

View of tools kept in a box Items in tool kit for attending buffer interlocking

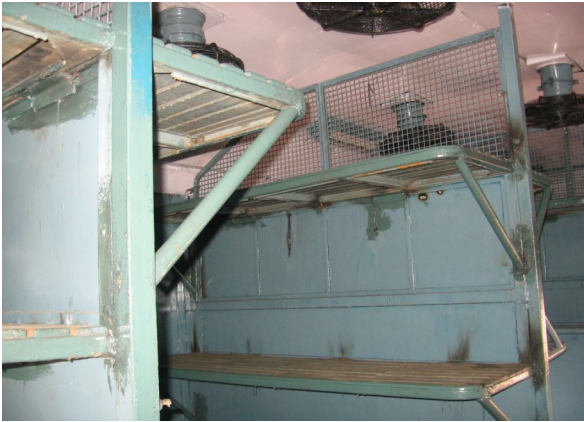
Racks provided in SR MFD 92445

Modified to increase the utility of the coach with new racks provided inside the coach. Exhaust pipe provided for 15 KWA generator. This developed at TVC coaching depot.

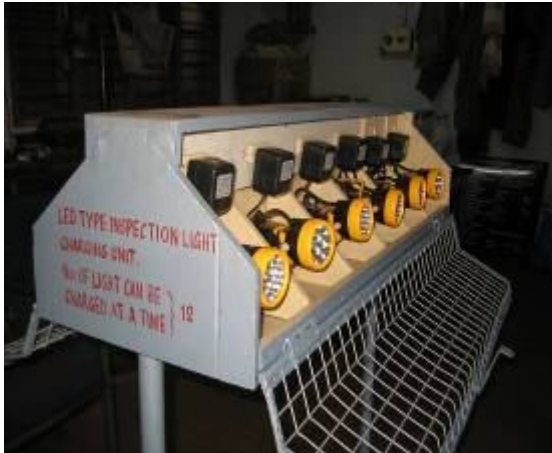
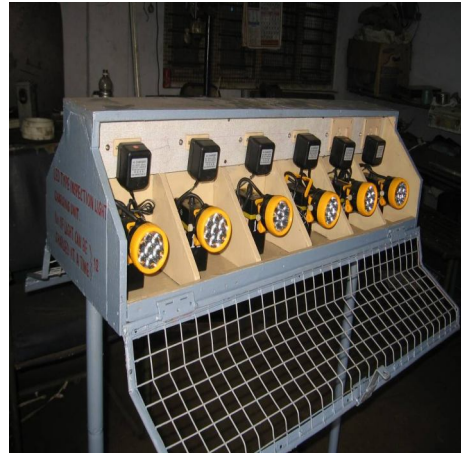
**Charging cubicle for LED type inspection lamp** developed in Thiruvananthapuram coaching depot with dimension of Length – 950mm, Width – 370mm & Height – 1100mm.

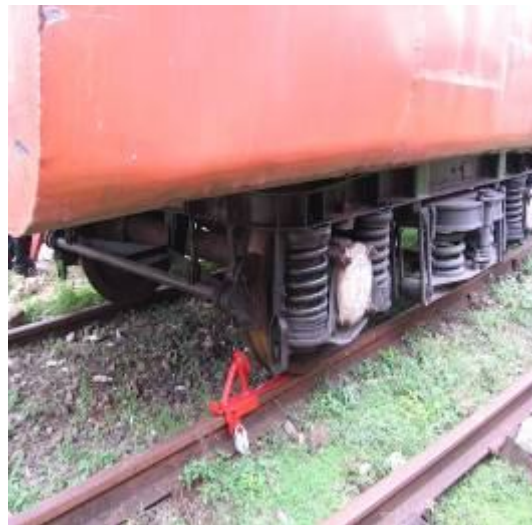
**Skid with locking provision for** securing of AEMV/ART coaches on track is developed by Thiruvananthapuram coaching depot.

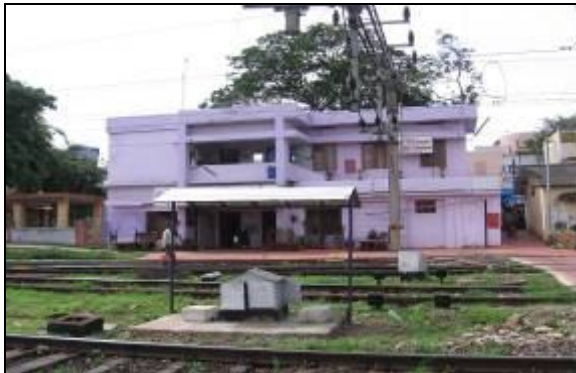
Shelter between PF No. 1 & 2

Three numbers of Rolling in examination shelters are fabricated in Thiruvananthapuram coaching depot and erected between PF 1 & 2, PF 2 & 3, and PF 3 & 4.

Length - 2.4 Metres  
Width - 1.4 Metres  
Height - 1.7 Metres.

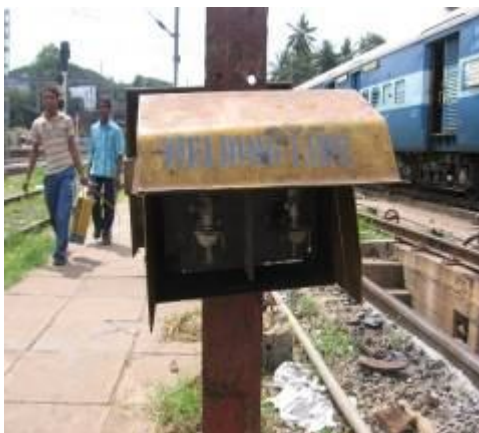
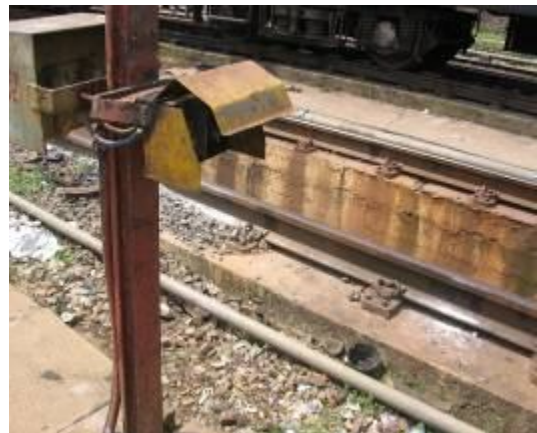
**Extension of welding cable in pit 1 at Thiruvananthapuram Coaching depot**

Welding line was not available at NCJ end of pit I of Thiruvananthapuram Coaching depot for 3 coach length due to which coaches placed at NCJ end of Pit I were used to mark sick if there is any welding repairs. By extending the welding cable, the depot is able to cater the welding needs at NCJ end of pit I & Pit 2. Separate Work and Earth cables have been provided with clamps at 2 coach interval through out the pit line I to avoid short circuit, rail earthing and damage that may caused to Roller bearing while doing welding on coaches.

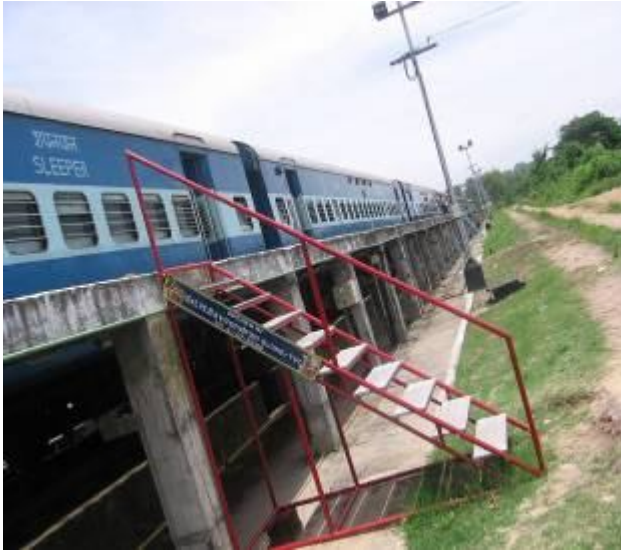
### 1. Provided Ladder for Pit line Cat Walk at KCVL

There was no provision of ladders on either side of KCVL pit line for climbing over catwalk for moving men and materials in to the compartment. This was pointed out by CME/MAS during his inspection at KCVL on 20.06.2009. To overcome this difficulty a special ladder has been designed, fabricated and erected by staff of TVC coaching depot, central successfully.

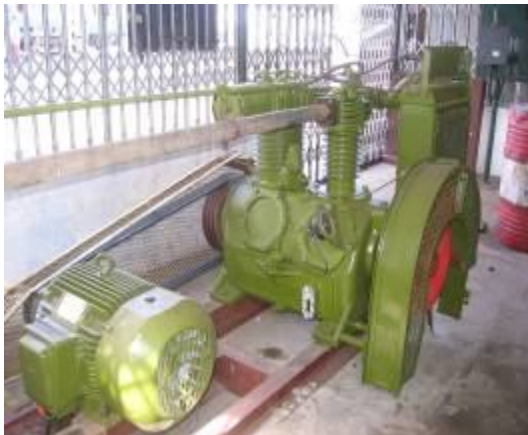
### 2. Expresser converted air compressor commissioned

An Expresser converted air compressor received from GOC Workshops has been commissioned at TVC coaching depot. This enables air testing of coaches in IOH/ Sick line without starting heavy duty air compressors (80 HP/ 360CFM) available at TVC coaching depot. Considerable amount of energy can be saved by this air compressor. More over this can be used for rake testing in pit line also.

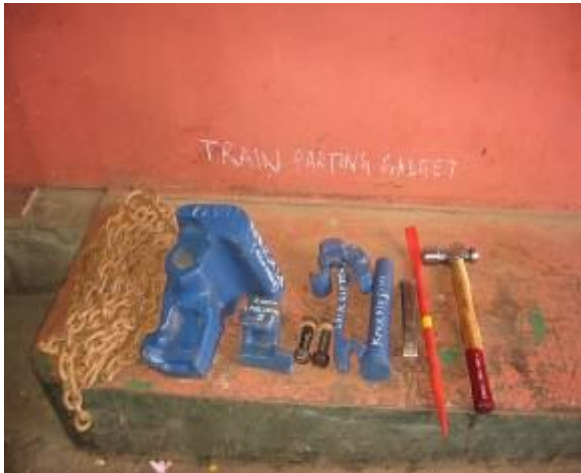
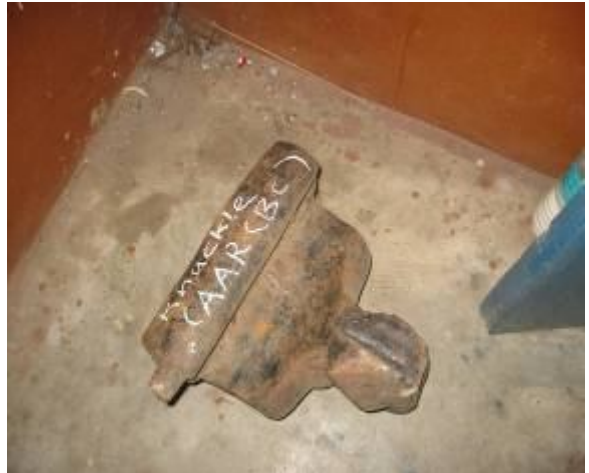
### 1. Gadget for attending Train Parting

A gadget for attending Train parting has been prepared and kept in the depot for use during emergencies.

- a) Breakage of Knuckle in AAR type CBC
- b) Breakage of Yoke in Alliance II CBC
- c) Breakage of Lock in Alliance II CBC

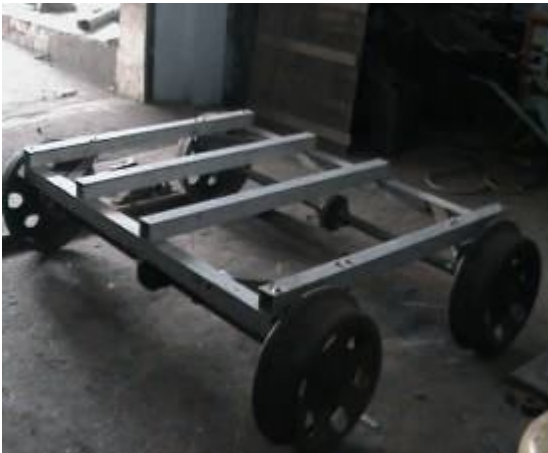
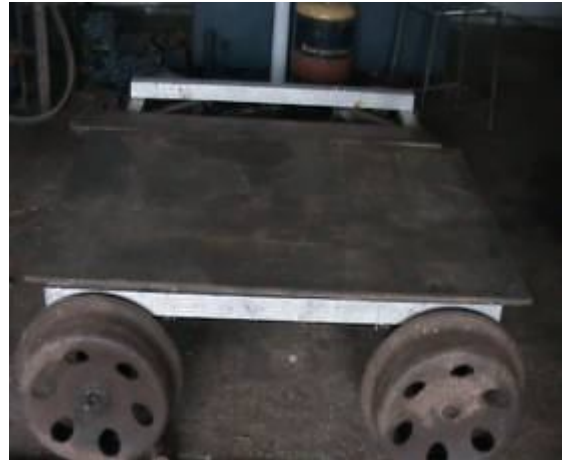
Modified Trolley for ART

A light weight trolley made with aluminium frame which was brought from CWM / IZN in the year 2005 for the use of ART /TVC had got an inherent draw back in which the wheels of the trolley will derail at crossings and also while negotiating curves which was not at all desirable at accident sites. Since the wheels are fitted independently, while negotiating curve, every chances are there to derail it.

To sort out this issue the trolley was modified by utilizing two push trolley wheels brought from SSE/ Pway /TVC. Hence now ART equipments can be transported safely with this trolley on emergencies.

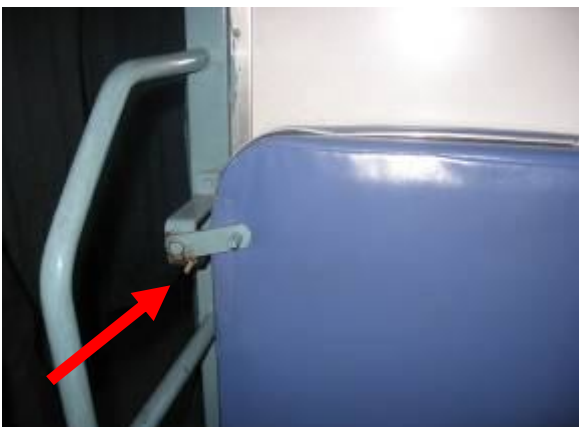
Modified latch for Berth cum back rest

Falling of berth cum back rest during run in ICF built second AC coaches due to poor holding of latches have been reported from public. This is either due to the member of latch which is coming in contact with berth cum backrest rotating freely as tension of the spring getting lost or there is no stopper preventing it from rotation. To overcome this problem a stopper has been welded in the latch at TVC coaching depot.

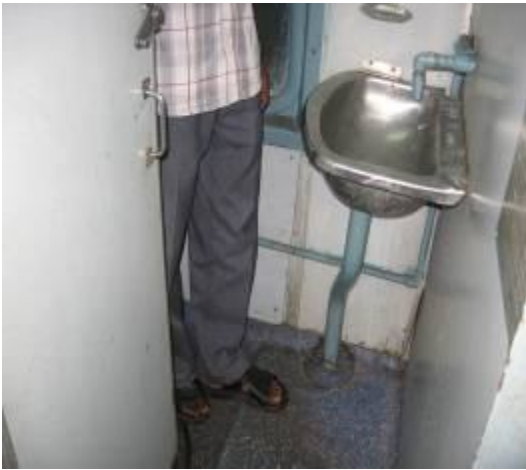
Before fitment

MOSR (A) had made a remark while traveling by Train number 6346 TVC – LT (T) Express in that one Lavatory door unable to open fully in a second AC coach SR ACCW 00060. On examination it was noticed that clearance between wash basin and lavatory door when lavatory door opened is very less when compared to other lavatory doors of the same coach. It is difficult for a passenger to pass through the gap. Hence clearance was increased by replacing the present wash basin with smaller one and fitted at one corner of the toilet at TVC coaching depot.

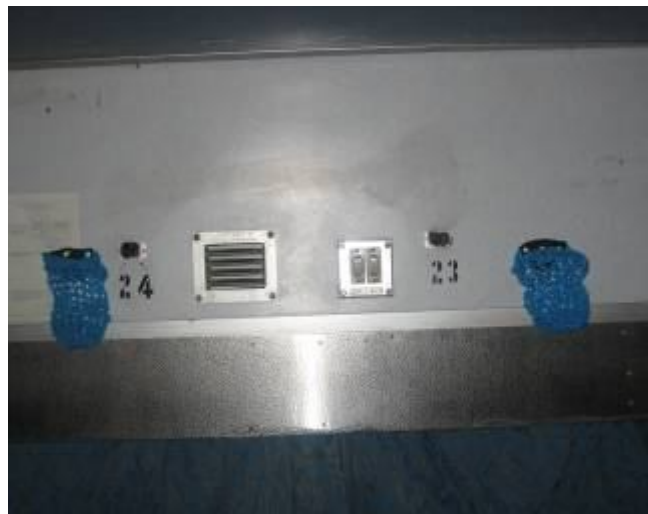
Tumbler holder

Fitted recently procured tumbler holder made of nylon wire in coaches during IOH by pop riveting at TVC coaching depot.

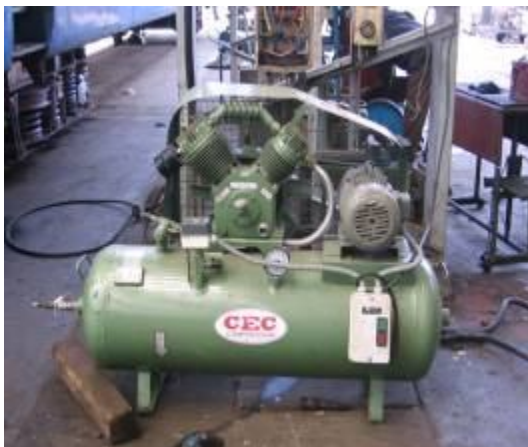
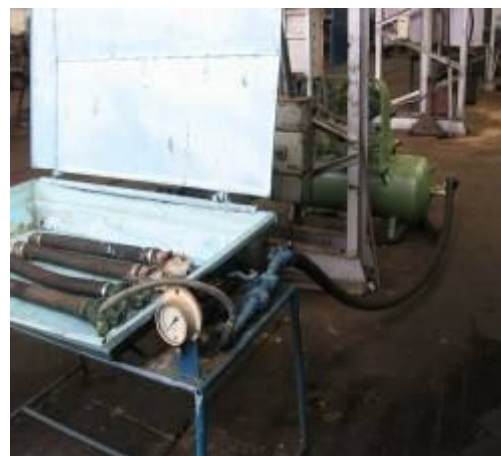
Thiruvananthapuram Coaching Depot's IOH facility has been provided with BP and FP hose testing facility. Even though the required pressure is 10Kg/cm<sup>2</sup>, due to non availability of air compressor generating 10 kg/cm<sup>2</sup> (Maximum working pressure of air compressor has been set at 7 Kg/cm<sup>2</sup>) a new air compressor generating 10 kg/cm<sup>2</sup> was procured recently and commissioned exclusively for this facility.

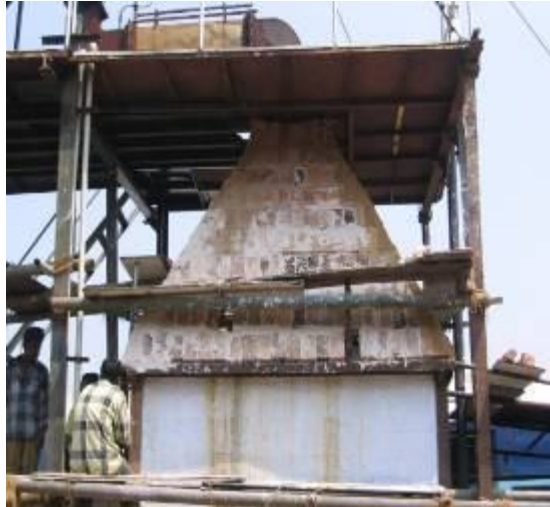
After repair out side view

Thiruvananthapuram, Coaching Depot has been provided with an incinerator, commissioned in the year 2006. Due to continuous use at very high temperature, RCC conical structure insulated with fire bricks totally collapsed and was under break down for the past two weeks. TVC depot took this work and conical part of the incinerator strengthened from out side with rails, steel strips, fire bricks and allied materials. Fire bricks and allied materials supplied from workshops (GOC, PWP & PWL) and rails and used tie bars received from engineering department. Now the incinerator is functioning properly.

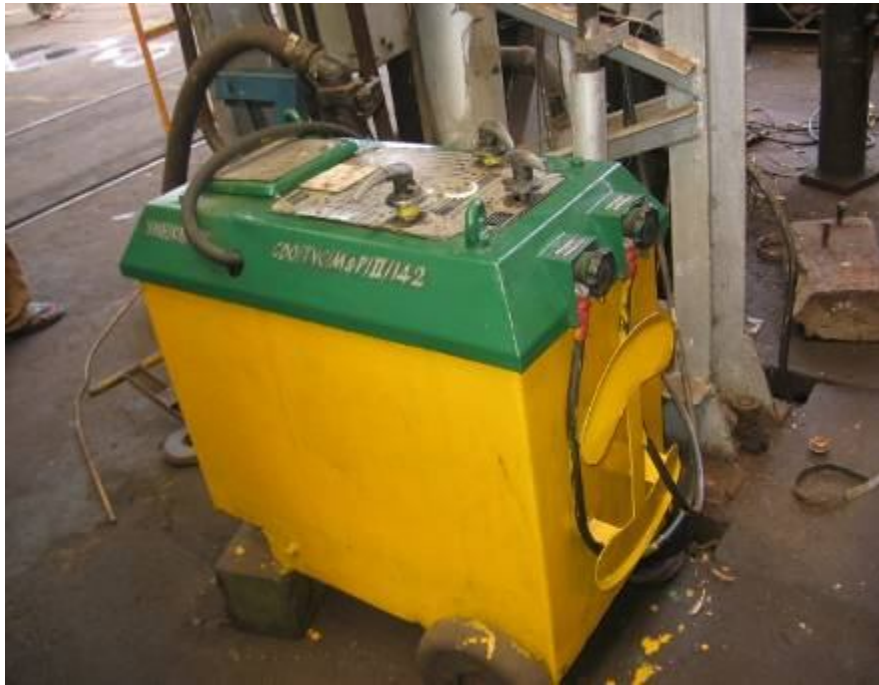
**Overhauling of welding plant -**

One of the ESAB make welding plant available at Thiruvananthapuram, Coaching Depot went out of order due to over heating at the time of welding. The M&P wing of the coaching depot overhauled the welding plant and made in good working condition by carrying out the following repairs.

1. All the worn contactors re-built and used
2. All defective shoes replaced
3. All defective +ve and -ve terminals replaced.
