**REPORT**  
**THIRD PARTY AUDITING OF RAILWAY BRIDGES (PHASE I)**

(Job No: CED/CON/TMMP/SAS/2019312)

**Br. No. 136 ( $1 \times 6.1$  m) Stone arch bridge at km. 45/700-800 between  
Melattur & Tuvvur Stations**

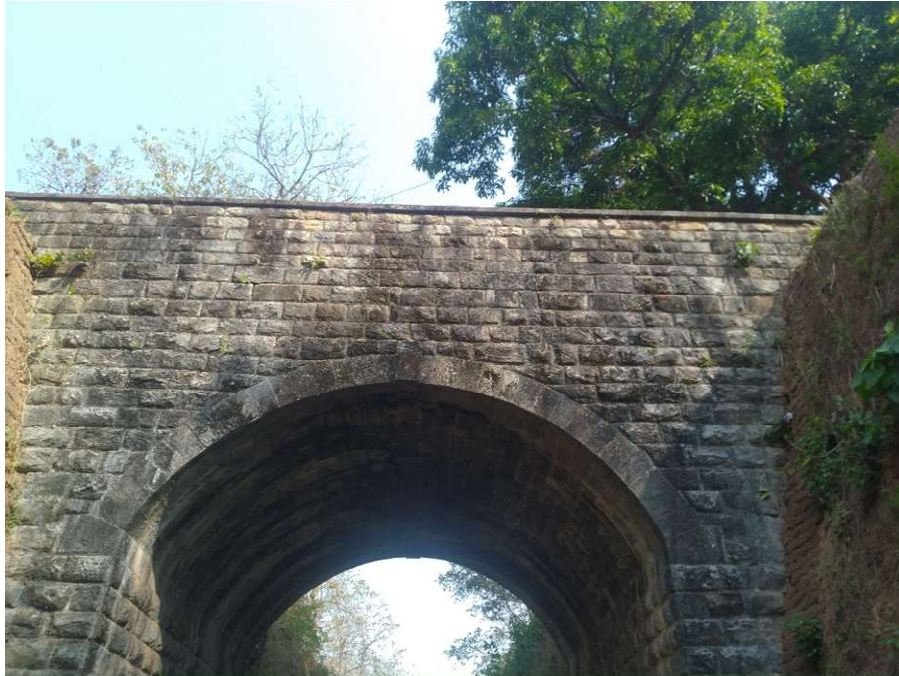
Figure 2. bottom view of the bridge

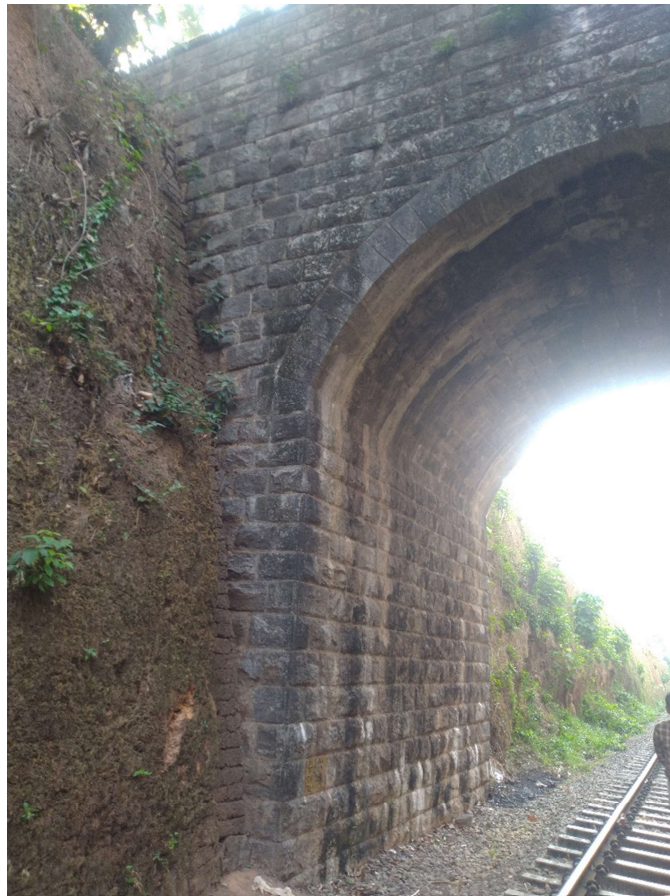
Figure 3. Abutment of the bridge

| Element | Defect Type<br>(Ref. Table 2<br>for details) | Follow-up actions<br>required | | | Remarks |
|---|---|---|---|---|---|
| Abutments | 07 | - | - | - | |

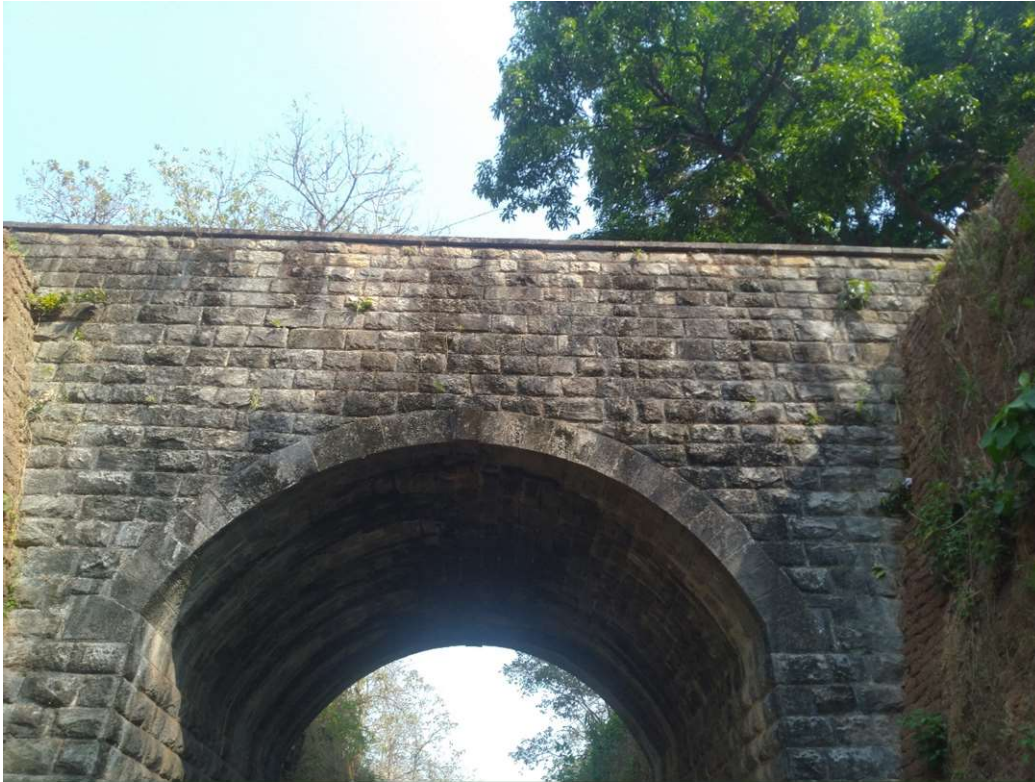
| Defect Type | Label | Defect Type | Label |
|---|---|---|---|
| Signs of overloading | 03 | Vegetation growth | 07 |

Figure 5. Vegetation growth in backfill near the bridge

Table 3 shows that arch bridge has sufficient reserved capacity against gravity loading and vehicle loading, thus it is found to be safe. The bridge is assessed to be stable also based on the visual inspection. In view of these the bridge is deemed to be **safe and stable**. It is suggested to monitor the bridge and the abutment on a regular basis and clean the unwanted vegetation growth which if neglected may lead to soil erosion and subsequent distress to the bridge.

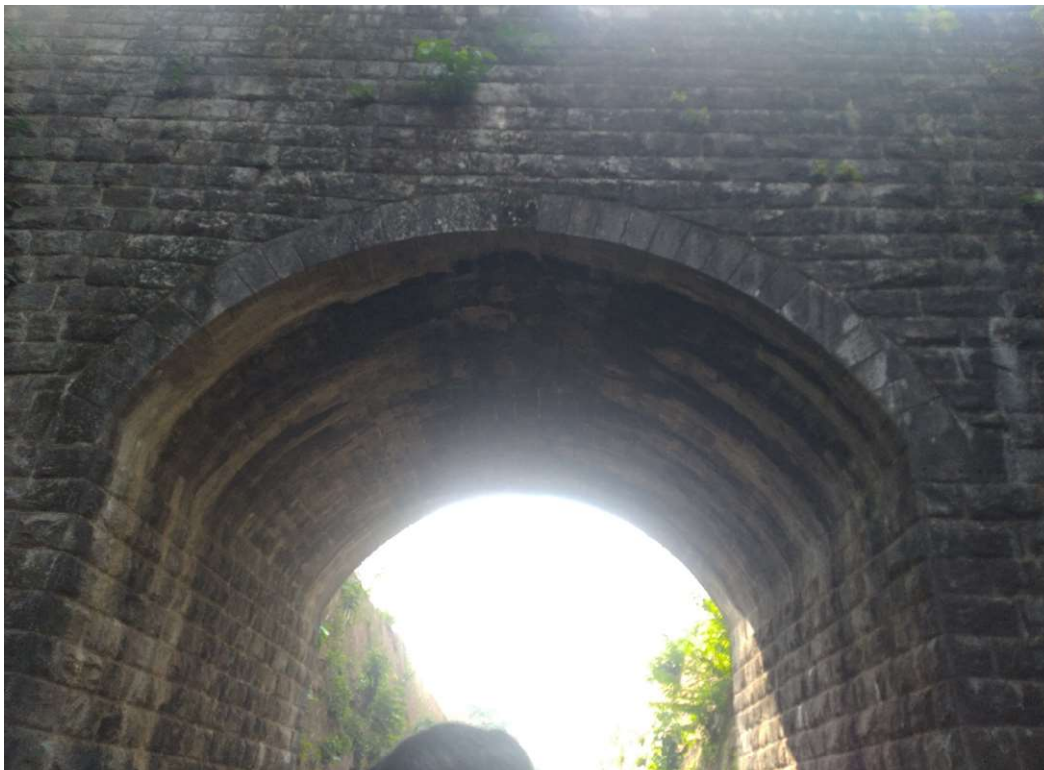
Figure 6. Vegetation growth above the crown

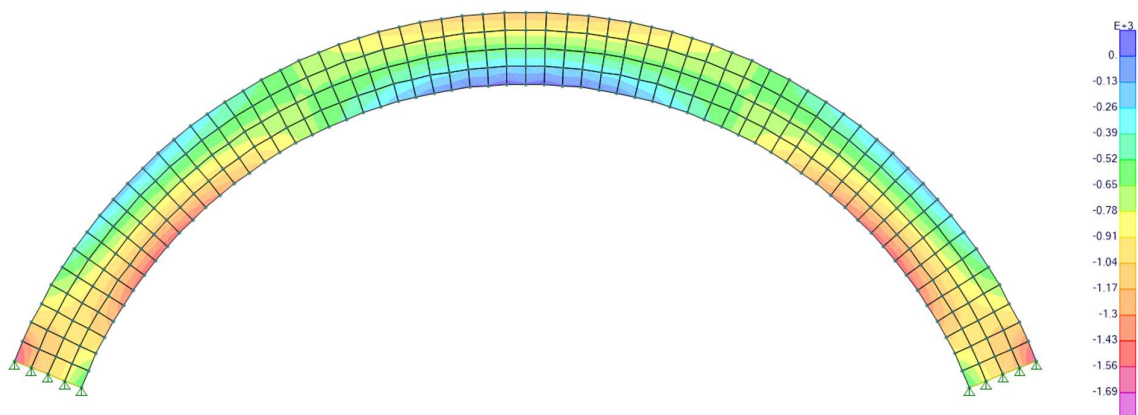
Figure 8. axial stress distribution along the span of arch

Axial compressive stress in the arch ring = 1.72 MPa < 2.5 Mpa

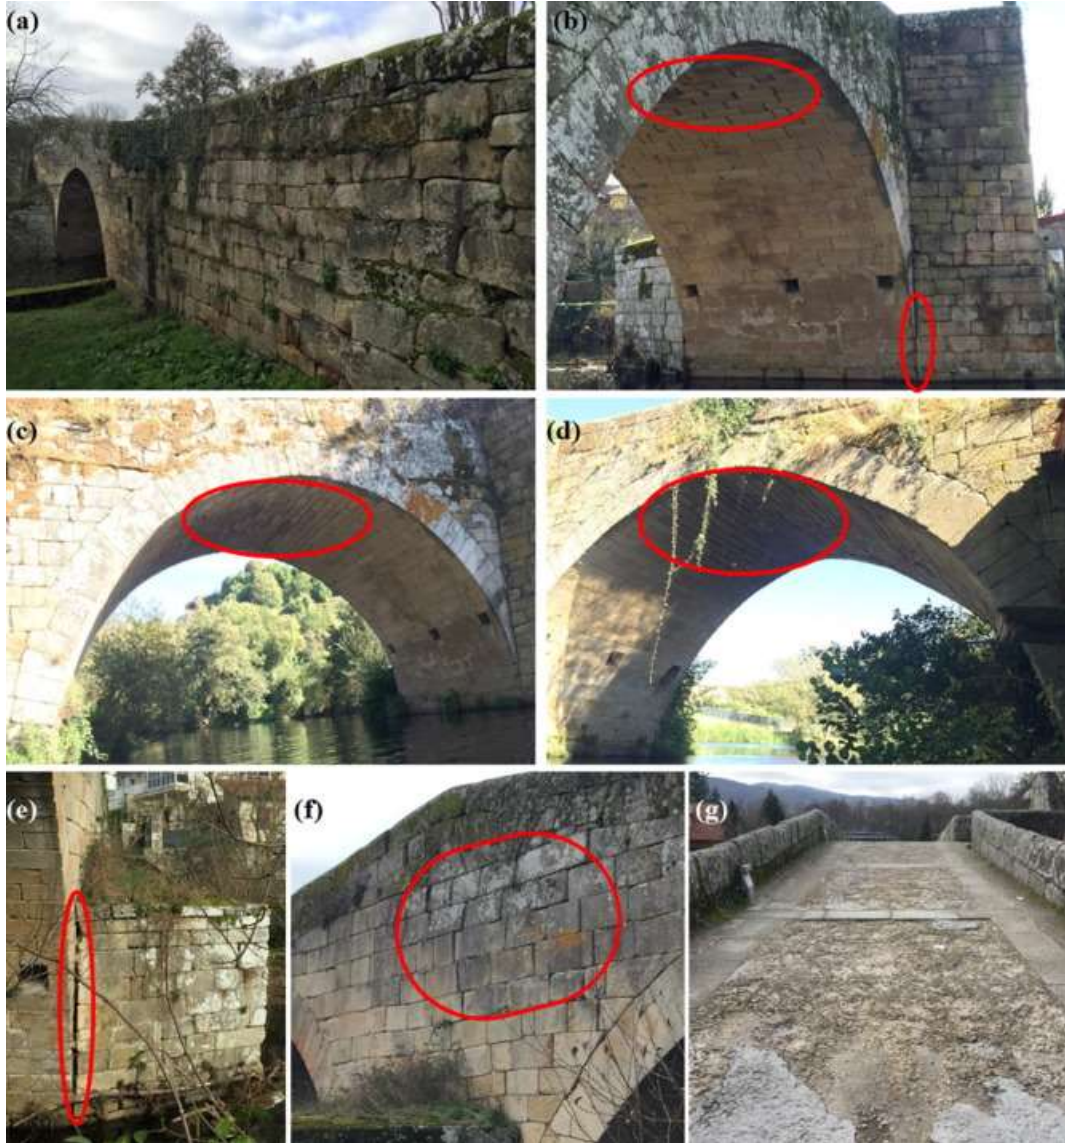
Stone arch bridges may fail due to different reasons. Some of the condition for failure of an arch bridge are shown in Fig.10.

Figure 10: (a) abutment (b) buttress (c) stone deterioration at the crown of arch (d) in-plane deformations of arch and stone deterioration at the crown (e) cutwater (f) out-of-plane deformations and cracks at the spandrel wall (g) damaged pathway.
