**REPORT**  
**THIRD PARTY AUDITING OF RAILWAY BRIDGES (PHASE I)**

(Job No: CED/CON/TMMP/SAS/2019312)

**Br. No. 1087 DN ( $3 \times 18.29$  m) Steel Girder at km.  
736/100 – 200 between Thalassery & Ettakot Stations**

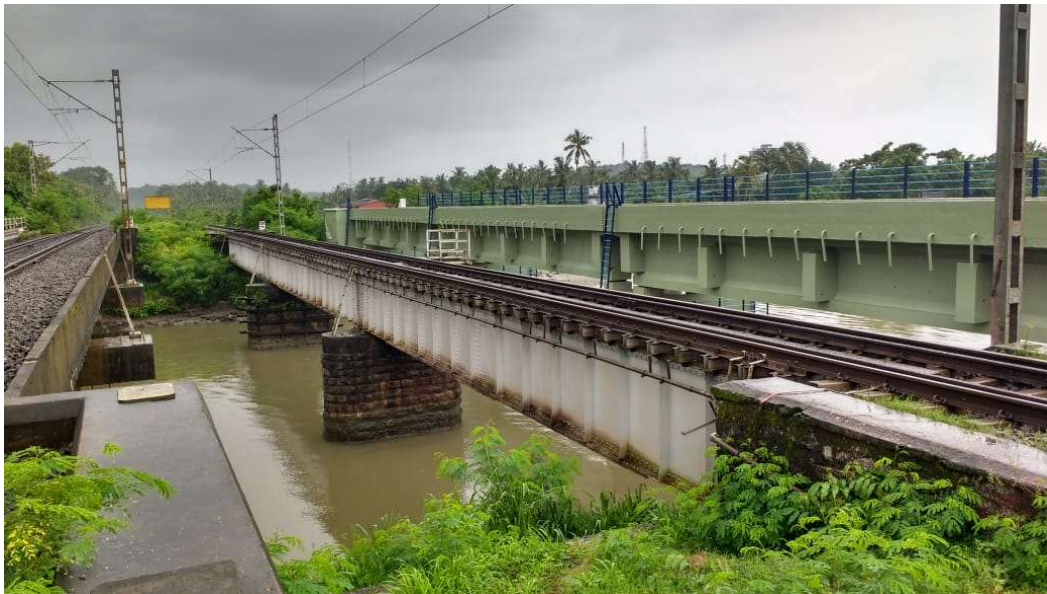
Figure 1. View of Br.1087 Plate girder bridge

The visual inspections along with field measurements were carried out on the bridge on 20 – 12 – 2019 (Friday) at 11.00 am. Officials from Kannur Railway section were also present during the inspection. Photographs of the bridge showing various elements are shown in Fig. 1 and Fig. 2. The bridge is a deck type riveted steel plate girder with three spans of 18.29 m, supported on Random Rubble (RR) masonry piers with masonry well foundation. Cement Concrete (CC) bed - blocks are seen on top of the RR masonry pier. One of the piers is seen to be strengthened by confining it with steel rails all around at four locations as shown in Fig.3. It was noted that the abutments were also of RR masonry. The bearings on the piers and abutments are of centralized steel sliding type. It was reported that the speed of the trains is restricted to 30 km/hr as the piers were showing signs of distress (in mortar joints). Vegetation growth is seen on pier as shown in Fig.3.

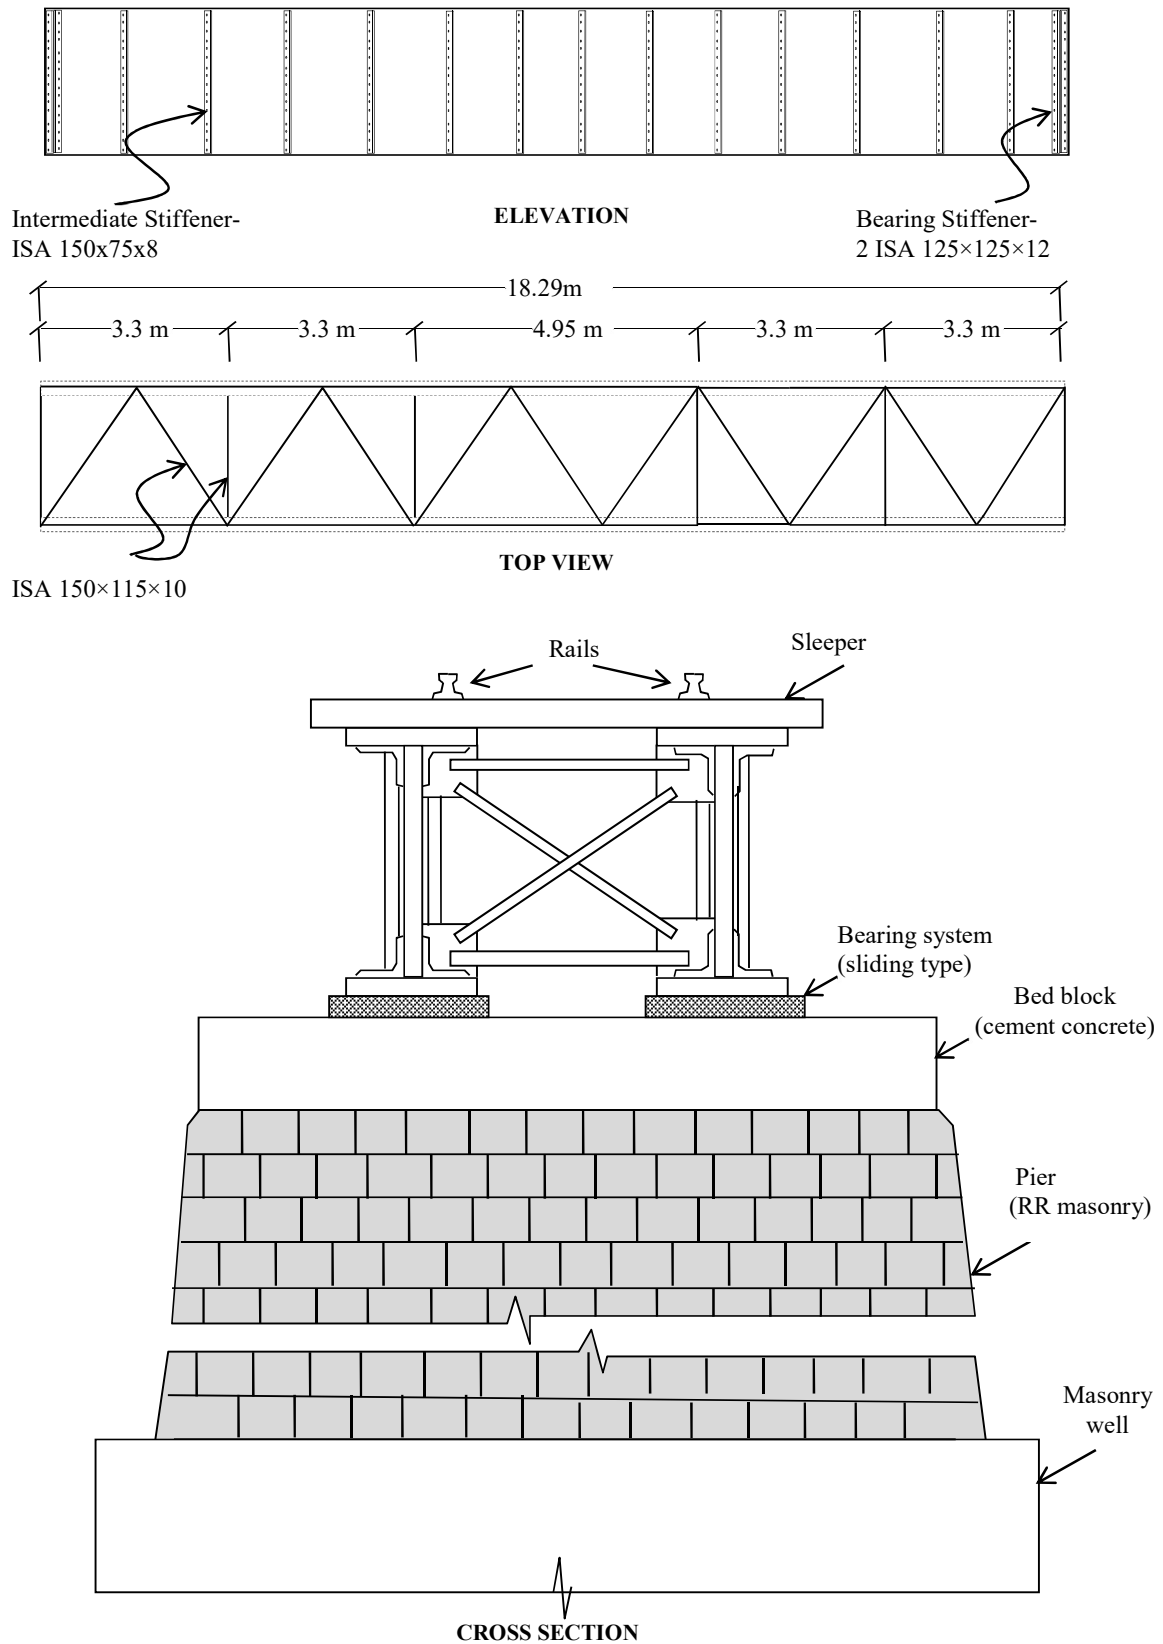
Figure 4. Geometrical details of the bridge (not to scale)

The geometry of the bridge is obtained by taking measurements in the field. Fig. 4 shows the details of geometry and typical member details. Based on a careful examination of the bridge, the results of observations are tabulated in the following Table 1. The Table shows various elements of the bridge, defect type, follow up actions required and remarks. Labels are assigned to various types of defects as given in Table 2.

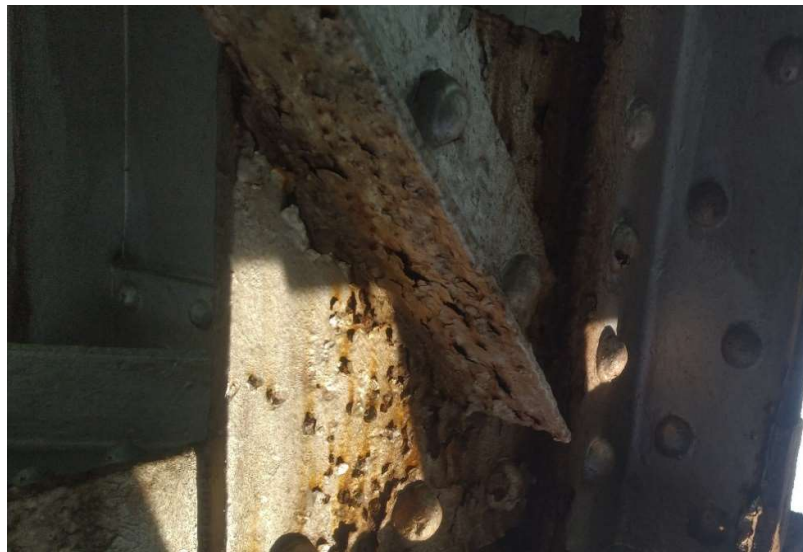
In the present bridge, severe corrosion has been noticed. Especially at the joints, it is seen that the gusset plate, flanges of girder and end cross bracings were corroded severely (Fig. 5 and Fig.9). Also, rivet heads at several locations were damaged. For many of the rivets, head is observed to be lost (Fig.6 and Fig.7), which is a matter of concern. The top flange of the girder has corroded considerably at several locations especially below the sleepers as shown in Fig.8. This is due to the wastewater from the toilets of the train. Flanges are noted to have become very thin at many locations due to corrosion. Material loss due to corrosion has been noticed in the horizontal bracings also. Corrosion in the web of the girder and intermediate stiffeners were minimal.

Figure 5. Corrosion and material loss in the gusset plate, cross-bracing elements

It has to be noted that the strength reduction due to fatigue is not considered here. If the maintenance is not done regularly and systematically, there is a possibility of further distress and strength reduction due to corrosion and fatigue. **Hence it is recommended to replace the corroded rivets, damaged members and connections at the earliest with new elements as per the existing design. As the flange plate and flange angle are having a DCR value of 1.01, it is suggested to replace the same with new elements as per the existing design.** Conclusions on the stability and safety of the bridge can be made only after conducting phase II of the audit.

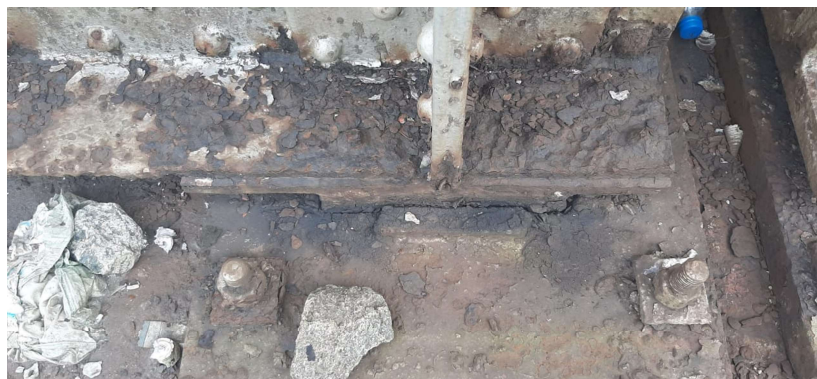
Figure 6. Corrosion of bottom flange over base plate

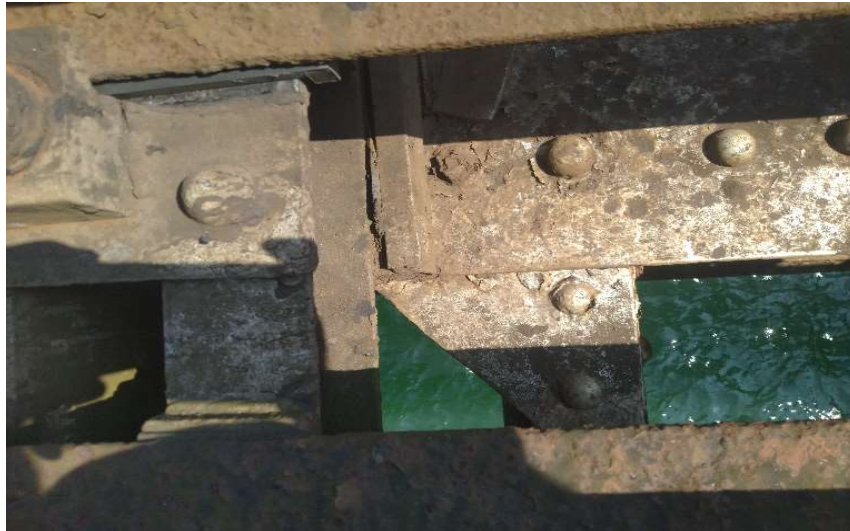
Figure 7. Severe corrosion in rivets

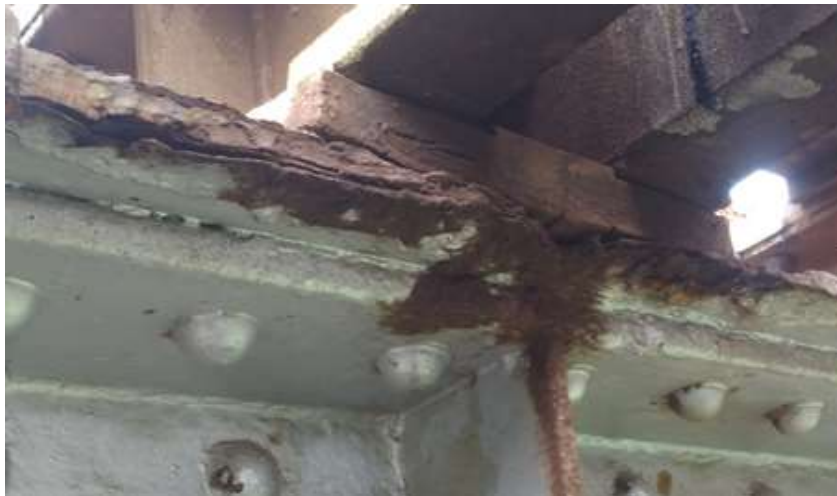
Figure 8. Corrosion in top flange under rail sleepers

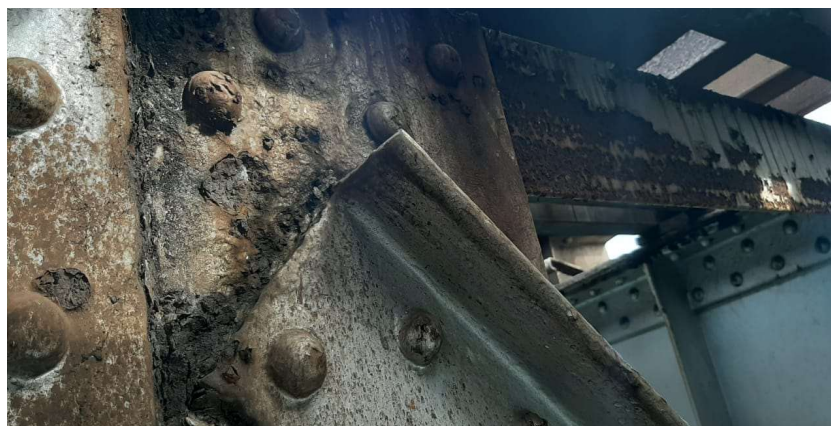
Figure 9. Corrosion in end cross bracing

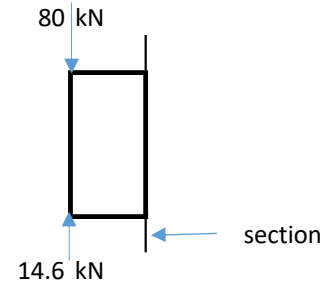
Considering a horizontal section cutting the end lateral as shown Fig.2. For Calculating the forces in the lateral, the part of Left section is considered

$S \cos 41.7 = 65.49$  kN

$S = 87.75$  kN
