# **REPORT**

## **THIRD PARTY AUDITING OF RAILWAY BRIDGES (PHASE I)**

**Br. No. 754 ( $1 \times 11.20\text{m} + 1 \times 14\text{m} + 1 \times 23.6\text{m} + 1 \times 18\text{m}$ ) IRS type at km  
578/700-800 at Shornur Junction**

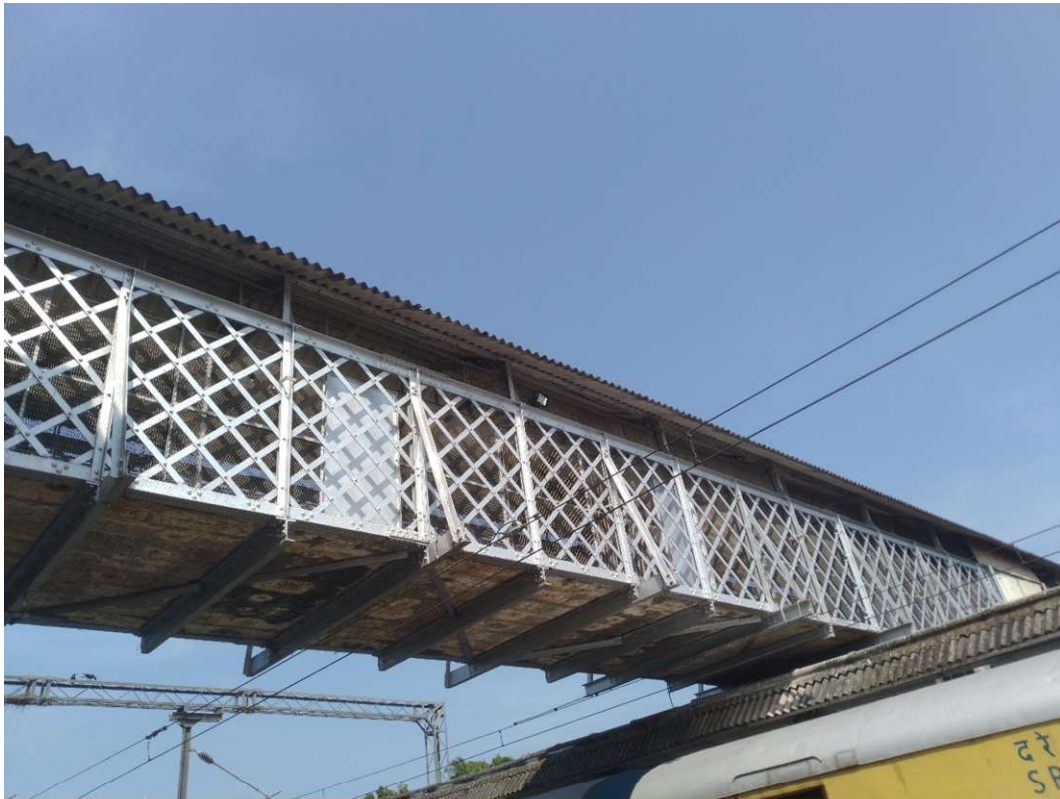
Figure1. FOB Shornur

First and second spans are 11.2m and 14m long respectively. These two spans together connect 1<sup>st</sup> platform and the 2<sup>nd</sup> platform. The bottom of the girder of this span is at a height of 5.15 m from platform level. Members of the truss are connected to each other through rivets and bolts (Figure.3), and the truss itself is connected to the steel column at both ends by bolted connections. It was noted that the section of bottom chords, floor beams, and bottom laterals of the truss were corroded at some locations. In these spans MS flat (65 mm×6 mm) are used as bracing (Figure.1)

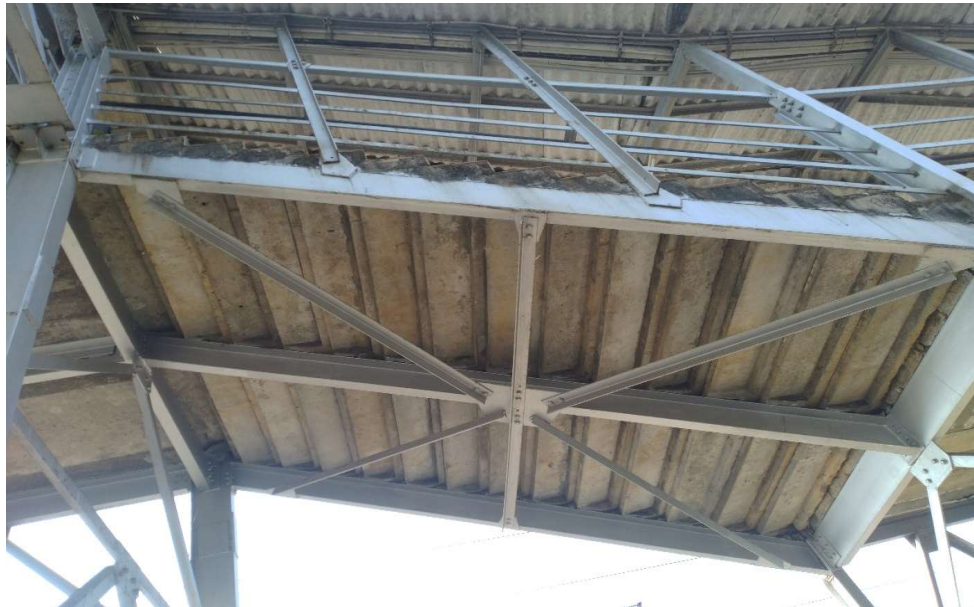
Figure 2. Stair side beams and tie beams

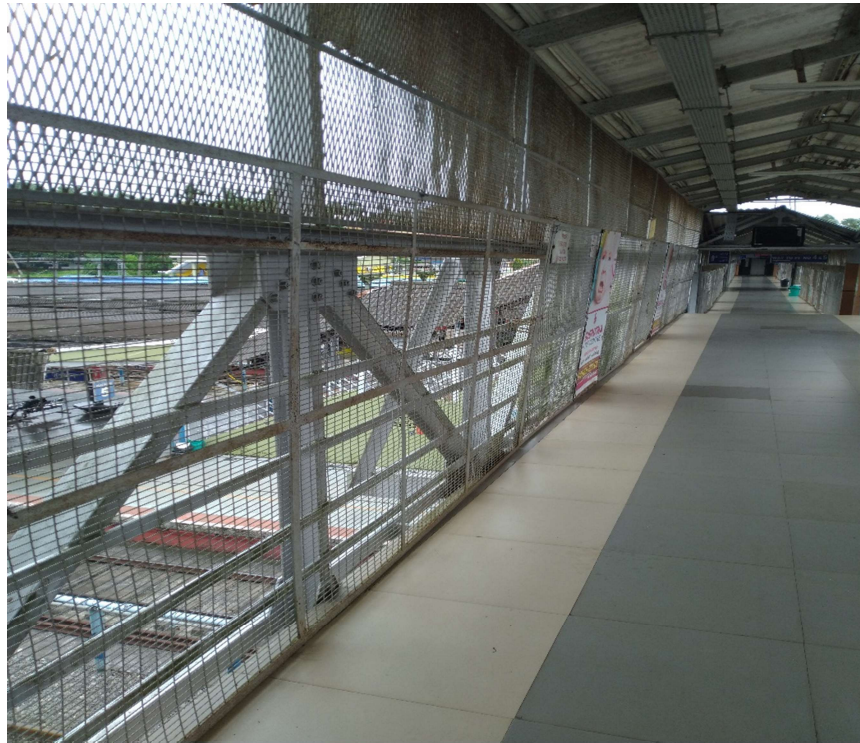
This span is 18m long and it connects 5<sup>h</sup> platform and the 6<sup>th</sup> platform. The bottom of the girder of this span is at a height of 5.6 m from platform level. Members of the truss are connected to each other through gusset plate with weld and truss itself is connected to the steel column at both ends by bolted connections. It was noted that the angle sections of bottom chords and channel sections of cross beams of the truss were corroded at several locations. The effect of corrosion is assessed to be minimal in this span.

Figure 3. Truss members connected through gusset plates

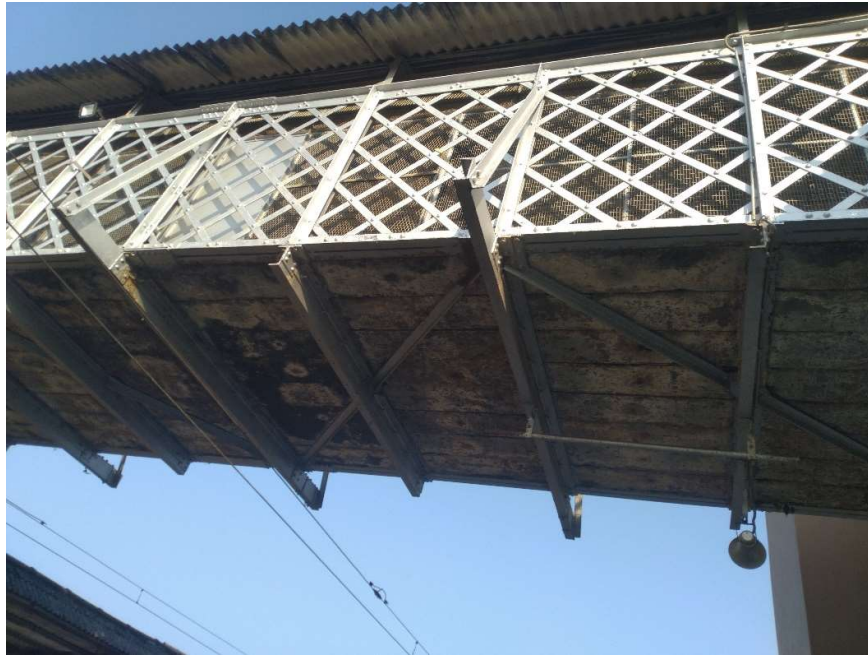
Figure 5. Typical floor beams and bottom laterals of first three spans

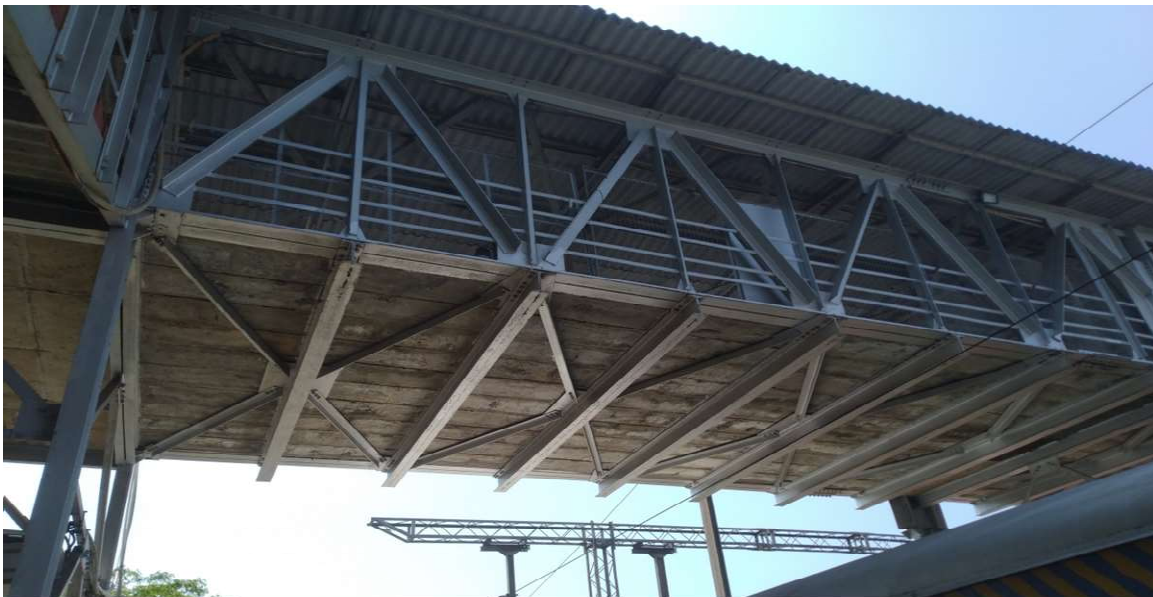
Figure 6. Floor beams and bottom laterals of fourth span

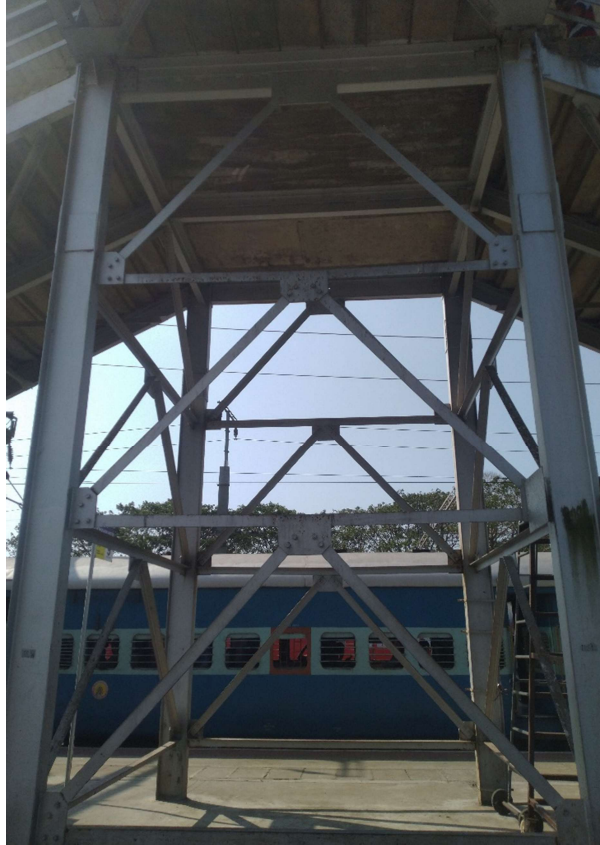
Figure 7. Columns and bracings

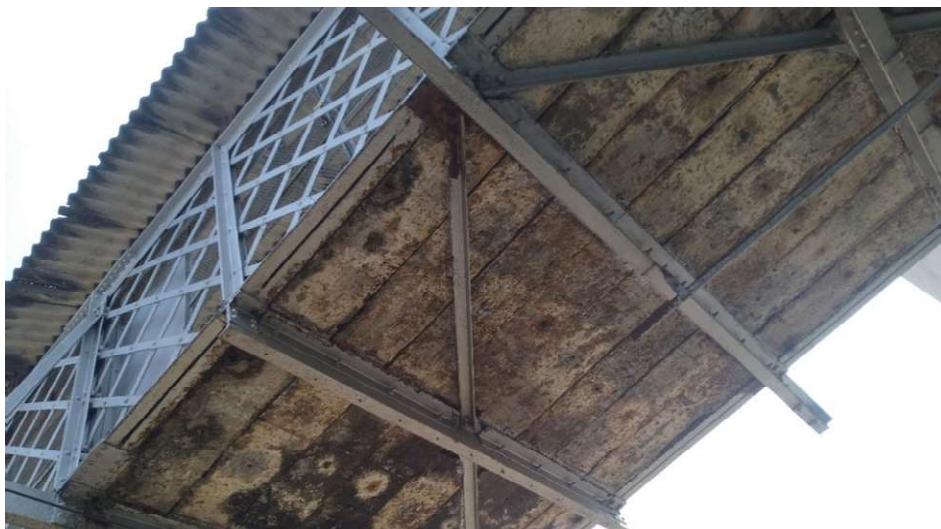
However the effect of corrosion is assessed to be minimal. Here also MS flat (65mm × 6mm) are used as bracing.

Figure 8. Corrosion of bottom laterals

| Element | Defect Type<br>(Ref. Table 2<br>for details) | Follow-up actions<br>required | | | Remarks |
|---|---|---|---|---|---|
| Bottom laterals | 02 | - | - | - | |
