**REPORT**  
**THIRD PARTY AUDITING OF RAILWAY BRIDGES (PHASE I)**

(Job No: CED/CON/TMMP/SAS/2019312)

**Br. No. 872A (1 × 21.5m) RCC Girder at km. 623/300-400 between  
Tirunavaya and Tirur station**

**SOUTHERN RAILWAY PALGHAT DIVISION**

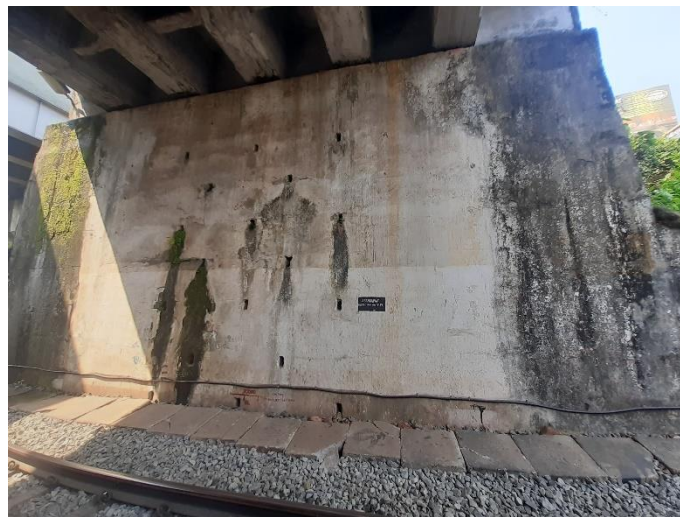
Figure 2. Concrete abutment

| Sl. No. | Elements | Remarks |
|---|---|---|
| 1 | Abutment | Both abutments are found in sound condition. No cracks / bulging of concrete is noticed. Spalling of concrete is noticed at some locations on abutment at eastern side as shown in Figure 8. |

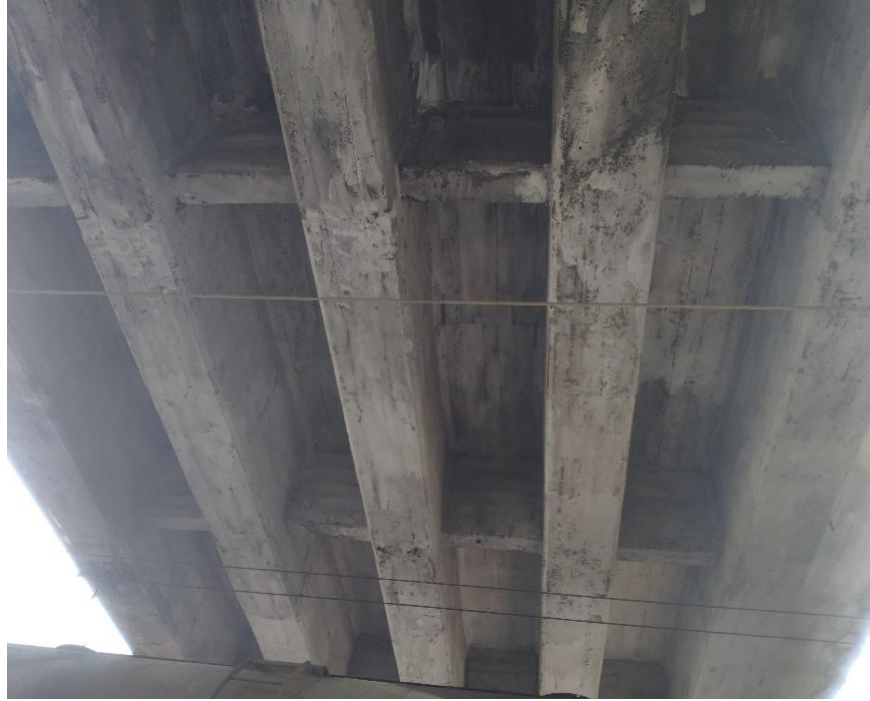
Figure 3. Bottom main beams and Cross beams

| Sl. No. | Elements | Remarks |
|---|---|---|
| 4 | Cross Girder | Cross girders are found in good condition |

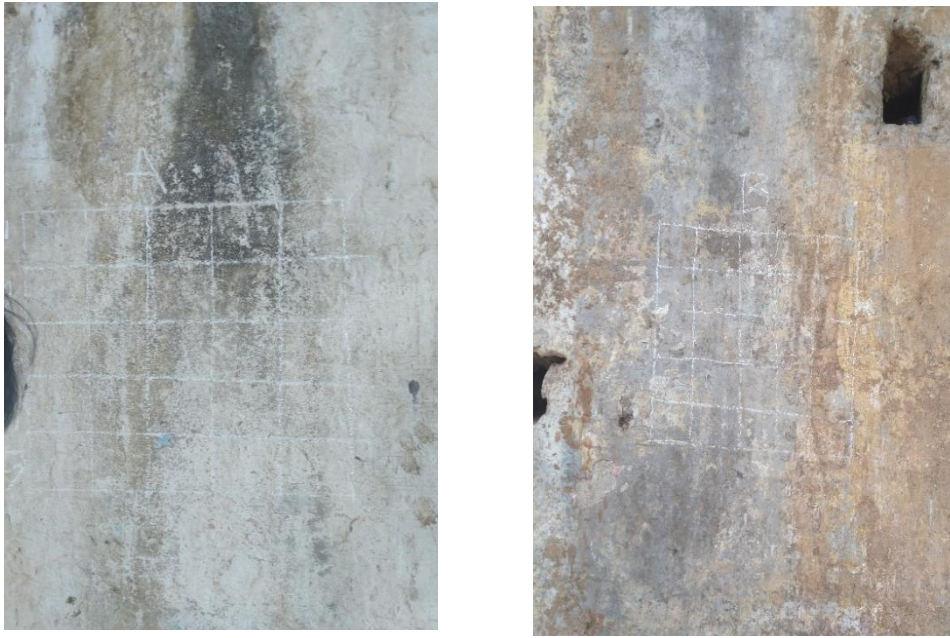
Figure 9. Testing points at

It is noted that the strength estimated by rebound hammer tests are by and large satisfactory. Hence it is inferred that the structure is in good condition.
